SACRIFICIAL ANODE VHS-8339 – ZN ALLOY – MODERN TIMES

Artefact name Sacrificial anode VHS-8339

Authors Marianne. Senn (EMPA, Dübendorf, Zurich, Switzerland) & Christian. Degrigny (HE-Arc CR, Neuchâtel, Neuchâtel, Switzerland)

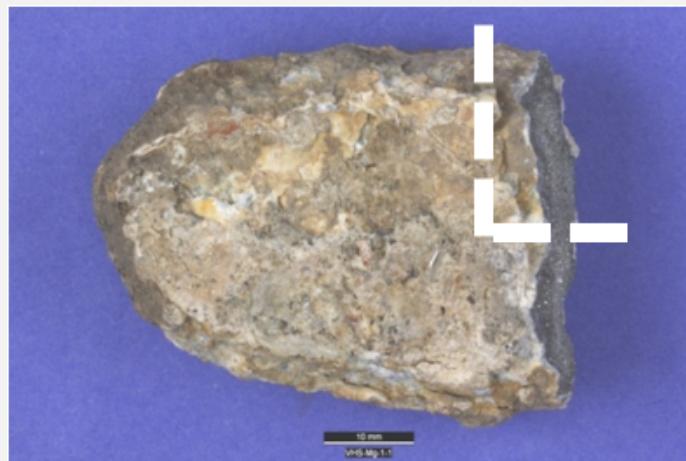
Fig. 2: Location of sampling area,

The sample (Fig. 3) shows a cross-section from the sacrificial anode (Fig. 2). The thickness of the corrosion crust is variable. Dimensions: L = 17mm; W = 14mm.
