TOWEL BAR – AL ALLOY – MODERN TIMES – FRANCE

Artefact name Towel bar

Authors Christian. Degriigny (HE-Arc CR, Neuchâtel, Neuchâtel, Switzerland)

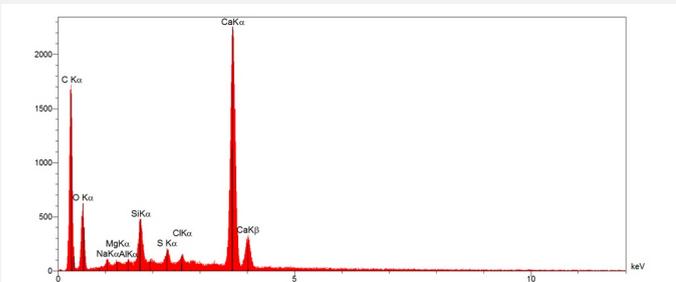
A very thin and loose oxide film has formed on the metal surface (CP1) and is locally covered by white deposits (D1). Intergranular corrosion has developed under the deposits (Fig. 7). Analysis by SEM-EDS indicates that the Al and O-rich oxide layer is contaminated with P and Si (area 1 on Fig. 7 and Fig. 8). These elements are even more present at the interface between CM1 and CP1 with Cl and S (area 2 on Fig. 7 and Fig. 9). The concentration of P and Si decreases in CM1 (area 3 on Fig. 7 and Fig. 10) while the concentration of S and Cl increases (Fig. 11). The deposit is mainly constituted of Ca, O, C and Si (probably CaCO₃ and SiO₂, area 4 on Fig. 7 and Fig. 12).

Fig. 12: EDS spectrum of area 4 of Fig. 7,
