SHOE NAIL 2637 1370.B. – HYPOEUTECTOID STEEL – ROMAN TIMES – SWITZERLAND

Artefact name Shoe nail 2637 1370.B.

Authors Christian. Degrigny (HE-Arc CR, Neuchâtel, Neuchâtel, Switzerland) & Valentin. Boissonnas (HE-Arc CR, Neuchâtel, Neuchâtel, Switzerland) & Vincent Chappuis. (HE-Arc CR, Neuchâtel, Neuchâtel, Switzerland)

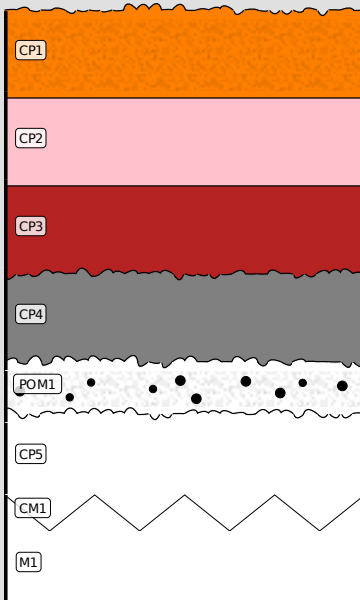
Fig. 6: Stratigraphic representation of the object in cross-section using the MiCorr application. This representation can be compared to Fig. 14, Credit HE-Arc CR, V.Chappuis.

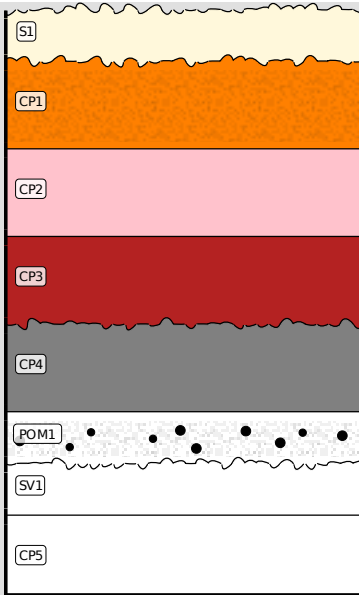
Fig. 5: Stratigraphic representation of the object in cross-section using the MiCorr application. This representation can be compared to Fig. 14, Credit HE-Arc CR, V.Chappuis.
