# HEADREST OR HORSE BIT VFIG 2003.7 - LEADED BRONZE - MODERN TIMES

**Artefact name** Headrest or horse bit VFig 2003.7

**Authors** Christian. Degriigny (HE-Arc CR, Neuchâtel, Neuchâtel, Switzerland) & Valentin. Boissonnas (HE-Arc CR, Neuchâtel, Neuchâtel, Switzerland)

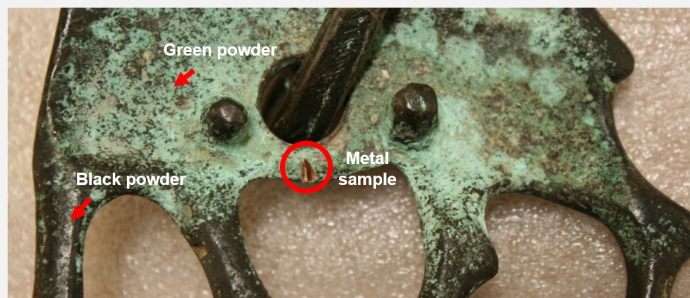
Fig. 2: Location of sampling areas,

<b>Description of sample</b>	The sample was cut on the bottom of one of the plates (Fig. 2). On Fig. 4, the top and round shape of the sample is the outer part of the metal. It is covered with corrosion layers. The lower part of the sample corresponds to the cut metal with no corrosion products.
<b>Alloy</b>	Leaded Bronze
<b>Technology</b>	Cast and cold worked (with final annealing?)
<b>Lab number of sample</b>	None
<b>Sample location</b>	HE-Arc CR, Neuchâtel, Neuchâtel
<b>Responsible institution</b>	Bible & Orient Museum, Fribourg, Fribourg
<b>Date and aim of sampling</b>	2014, metallography and chemical analyses
