# HEADREST OR HORSE BIT VFIG 2003.7 - LEADED BRONZE - MODERN TIMES

**Artefact name** Headrest or horse bit VFig 2003.7

**Authors** Christian. Degriigny (HE-Arc CR, Neuchâtel, Neuchâtel, Switzerland) & Valentin. Boissonnas (HE-Arc CR, Neuchâtel, Neuchâtel, Switzerland)

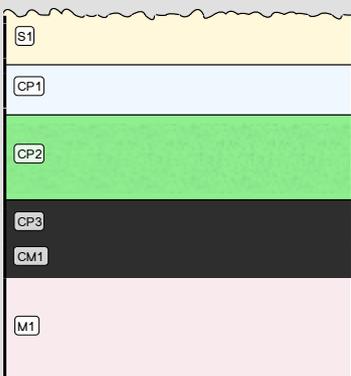
Fig. 5: Stratigraphic representation of the object in cross-section using the MiCorr application. This representation can be compared to Fig 11, Credit HE-Arc CR.

Based on the analyses carried out, the schematic representation of the stratigraphy of corrosion layers has been corrected: a thin, black sulphur-rich layer covers the metal surface. A thick green layer has developed on top and seems to be constituted mainly of atacamite enriched in lead with sediments on top.
