FUNERAL MASK IVC 11595 – CU/AG, WITH SURFACE ENRICHMENT (AG)

Artefact name Funeral mask Ivc 11595

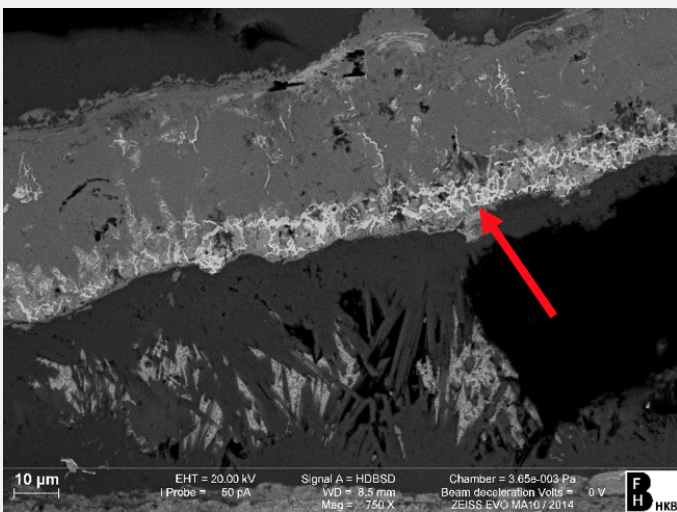
Fig. 8: SEM image of a partially refilled structural void with a silver-, copper- and mercury-rich layer (red arrow),

The silver sulphide (HgS, cinnabar, Fig. 14), present as a red pigment on the silver surface, could have been reduced through an electrochemical process in the presence of chlorides (Keune, K. (2005)). The released sulfur recombined with the silver to form black silver sulphide. Above that layer a porous mercury- and silver rich stratum has formed (see Hg & Ag on cartography Fig. 9). It remains unclear if the limitos is located in the silver enriched surface or within this silver-mercury compound (Fig. 8).

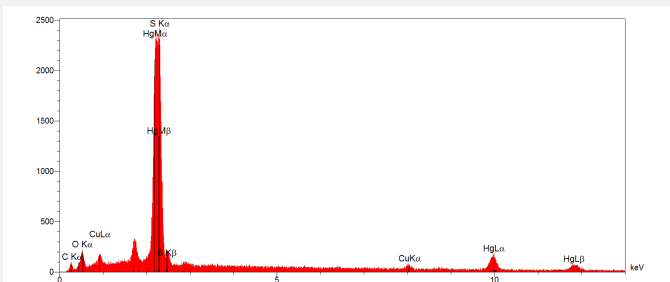
Figs. 11a and b: EDS analysis of the layer that appears light grey under polarized light, situated below the red layer (Fig.

4). Method of analysis: SEM-EDS, Lab of Electronic Microscopy and Microanalysis, IMA (Néode), HEI Arc,
