FUNERAL MASK IVC 11595 – CU/AG, WITH SURFACE ENRICHMENT (AG)

Artefact name Funeral mask Ivc 11595

Url /artefacts/400/

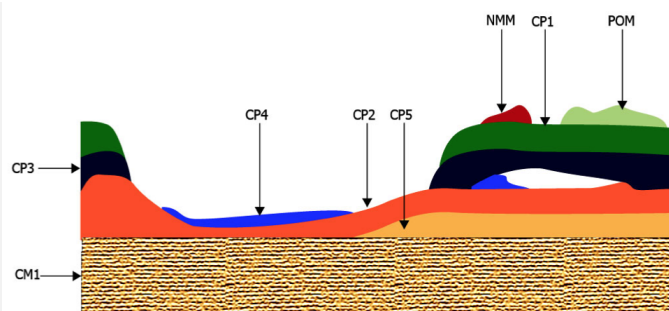
The schematic representation below gives an overview of the corrosion layers encountered on the object from visual macroscopic observation. The first stratigraphy (Fig. 3a) is for the front, while the second (Fig. 3b) represents the back.

Fig. 3a: Stratigraphic representation of the artefact in cross-section by macroscopic observation, face of the object,

Fig. 3b: Stratigraphic representation of the artefact in cross-section by macroscopic observation, back of the object,

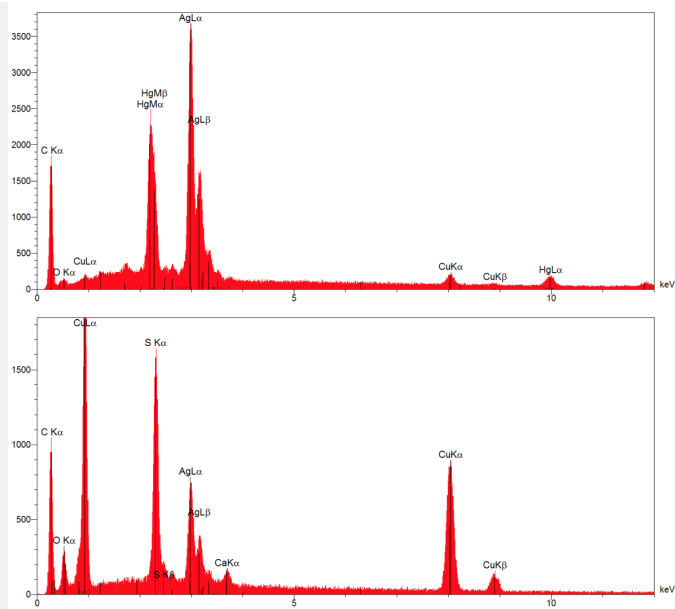
The silver enriched surface is entirely covered with copper corrosion products. The outer green layer (CP1) is a copper carbonate (Fig. 12, Table 1), while the red layers (CP2 in Fig. 5a ; CP4 and CP5 in Fig. 5b) are consisting of a copper oxide, most likely cuprite (Fig. 10). Below the cuprite and above the silver enriched surface on the front face a thin black layer is present (appears grey under polarized light). SEM-EDS analysis shows that in that stratum the mercury of the pigment (Fig. 14) has been transformed into a mercury-silver compound (Figs. 8 and 11a and b) which according to Raman spectrometry (Fig. 15) is not cinnabar anymore. In areas this silver- and mercury-rich surface has been pulled off by raising the corrosion layers, leaving structural voids that were subsequently filled by secondary corrosion products, most likely copper carbonates (Figs. 7 and 8)

Fig. 10: EDS analysis of the red corrosion layer (Fig. 4). Method of analysis: SEM-EDS, Lab of Electronic Microscopy and Microanalysis, IMA (Néode), HEI Arc,

Figs. 11a and b: EDS analysis of the layer that appears light grey under polarized light, situated below the red layer (Fig.

4). Method of analysis: SEM-EDS, Lab of Electronic Microscopy and Microanalysis, IMA (Néode), HEI Arc,
