VOTIVE FIGURE OF A BAT IVB4168 – GILDED BRASS

Artefact name Votive figure of a bat IVb4168

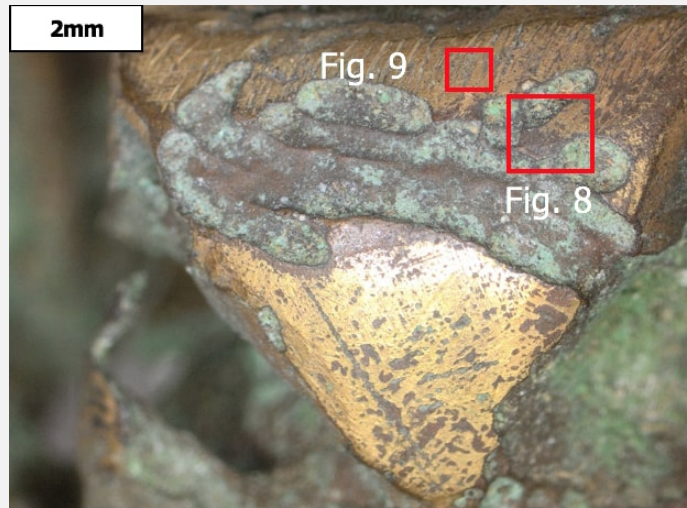
Fig. 7: Binocular image of the metal showing details of Figs. 8 and 9,

The metal seems to have been heavily attacked (acid dissolution). There are several perforations on the lower part of the object, and where the gold layer is absent the surface is unevenly pitted by corrosion (Figs. 1, 2 and 7). The submetallic core is not visible from the surface.

There are two corrosion products (Figs. 7, 8 and 9). The red one (CP2) has a submetallic brightness and is opaque, non-magnetic, compact, hard and adherent. It is very thin (less than a few microns thick) and only appears where the gold layer has been lost. The EDX spectrum (Fig. 10) shows that it is a Cu- and O rich product, probably cuprite (Cu₂O).

The light green to white corrosion product (CP1) has a waxy consistency and is thin, translucent, non-magnetic, powdery and very soft. It is very loosely bound. It is distributed on the whole object (front and back) as disparate clumps. It is mainly located on the cavities and irregularities of the surface. Its FTIR analysis (ATR mode) (Fig. 11) was performed on green and white areas of CP1. The two compounds have similar spectra and were identified as copper nitrate (Fig. 11b).
