DOMED CAP NUT – ZN AL SN CU ALLOY – MODERN TIMES – FRANCE

Artefact name	Domed cap nut
Authors	Christian. Degriigny (HE-Arc CR, Neuchâtel, Neuchâtel, Switzerland) & Mathea. Hovind (University of Oslo, Department of archaeology, conservation and history (IAKH-UiO), Oslo, Oslo, Norway)
Url	/artefacts/402/

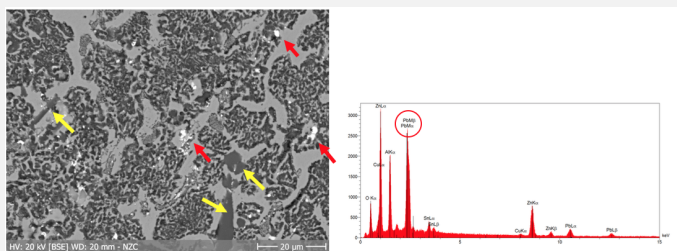
The metal of the domed fitting (M2) consists of a Zn/Al/Pb/Cu/Sn alloy (Table 1) externally covered by a nickel-based plating (M1) (Figs. 7 and 8). The bulk metal (M2) has a dendritic microstructure appearing light grey in bright field, while the interdendritic phase appears white (Fig. 9). The latter is Zn-rich, while the dendritic phase consists of approximately equal amounts of Zn and Al (Table 2, Fig. 11). Observation in SEM (BSE-mode) reveals the presence of Pb-nodules, visible as white irregular spots with a scattered distribution, in addition to opaque grey patches which are rich in Al and Fe (Fig. 10).
