# DOMED CAP NUT – ZN AL SN CU ALLOY – MODERN TIMES – FRANCE

<b>Artefact name</b>	Domed cap nut
<b>Authors</b>	Christian. Degriigny (HE-Arc CR, Neuchâtel, Neuchâtel, Switzerland) & Mathea. Hovind (University of Oslo, Department of archaeology, conservation and history (IAKH-UiO), Oslo, Oslo, Norway)
<b>Url</b>	/artefacts/402/

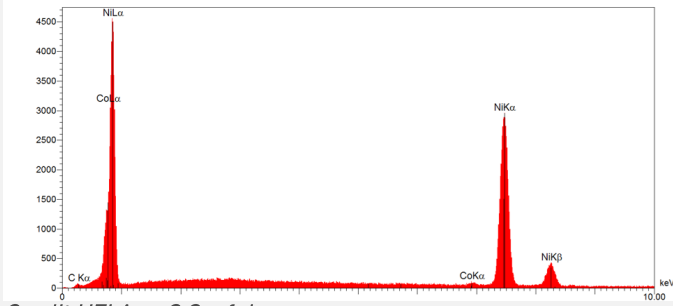
The metal of the domed fitting (M2) consists of a Zn/Al/Pb/Cu/Sn alloy (Table 1) externally covered by a nickel-based plating (M1) (Figs. 7 and 8). The bulk metal (M2) has a dendritic microstructure appearing light grey in bright field, while the interdendritic phase appears white (Fig. 9). The latter is Zn-rich, while the dendritic phase consists of approximately equal amounts of Zn and Al (Table 2, Fig. 11). Observation in SEM (BSE-mode) reveals the presence of Pb-nodules, visible as white irregular spots with a scattered distribution, in addition to opaque grey patches which are rich in Al and Fe (Fig. 10).

Fig. 8: EDS-spectrum showing the chemical composition of the metal plating (M1). Method of analysis: SEM-EDS. Lab. of Electronic Microscopy and and Microanalysis, Néode, HEI Arc,
