## TOWEL BAR – AL ALLOY – MODERN TIMES – FRANCE

Artefact name	Towel bar
Authors	Christian. Degriigny (HE-Arc CR, Neuchâtel, Neuchâtel, Switzerland)
Url	/artefacts/410/

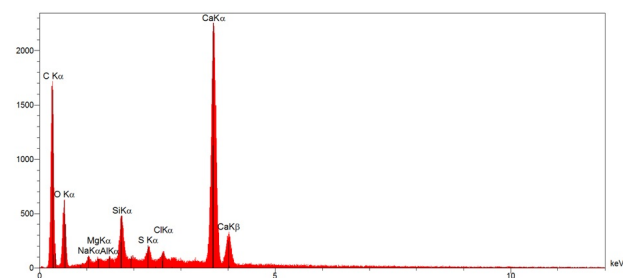
Fig. 12: EDS spectrum of area 4 of Fig. 7,

A very thin and loose oxide film has formed on the metal surface (CP1) and is locally covered by white deposits (D1). Intergranular corrosion has developed under the deposits (Fig. 7). Analysis by SEM-EDS indicates that the Al and O-rich oxide layer is contaminated with P and Si (area 1 on Fig. 7 and Fig. 8). These elements are even more present at the interface between CM1 and CP1 with Cl and S (area 2 on Fig. 7 and Fig. 9). The concentration of P and Si decreases in CM1 (area 3 on Fig. 7 and Fig. 10) while the concentration of S and Cl increases (Fig. 11). The deposit is mainly constituted of Ca, O, C and Si (probably CaCO3 and SiO2, area 4 on Fig. 7 and Fig. 12).
