TOWEL BAR – AL ALLOY – MODERN TIMES – FRANCE

Artefact name	Towel bar
Authors	Christian. Degriigny (HE-Arc CR, Neuchâtel, Neuchâtel, Switzerland)
Url	/artefacts/410/

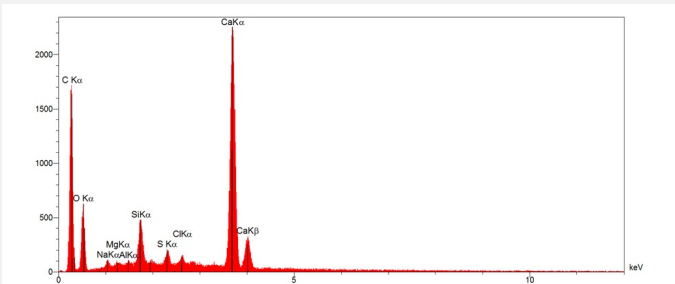
A very thin and loose oxide film has formed on the metal surface (CP1) and is locally covered by white deposits (D1). Intergranular corrosion has developed under the deposits (Fig. 7). Analysis by SEM-EDS indicates that the Al and O-rich oxide layer is contaminated with P and Si (area 1 on Fig. 7 and Fig. 8). These elements are even more present at the interface between CM1 and CP1 with Cl and S (area 2 on Fig. 7 and Fig. 9). The concentration of P and Si decreases in CM1 (area 3 on Fig. 7 and Fig. 10) while the concentration of S and Cl increases (Fig. 11). The deposit is mainly constituted of Ca, O, C and Si (probably CaCO₃ and SiO₂, area 4 on Fig. 7 and Fig. 12).

Fig. 12: EDS spectrum of area 4 of Fig. 7,
