# HEADREST OR HORSE BIT VFIG 2003.7 - LEADED BRONZE - MODERN TIMES

**Artefact name** Headrest or horse bit VFig 2003.7

**Authors** Christian. Degrigny (HE-Arc CR, Neuchâtel, Neuchâtel, Switzerland) & Valentin. Boissonnas (HE-Arc CR, Neuchâtel, Neuchâtel, Switzerland)

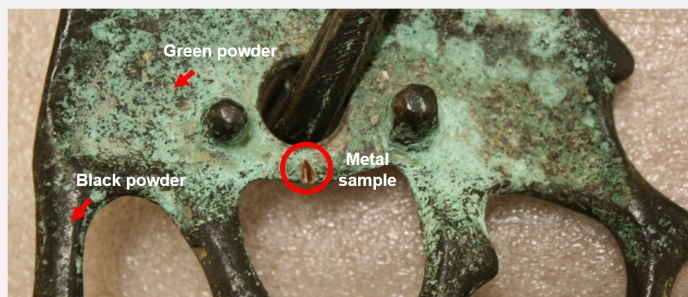
Fig. 2: Location of sampling areas,

<b>Description of sample</b>	The sample was cut on the bottom of one of the plates (Fig. 2). On Fig. 4, the top and round shape of the sample is the outer part of the metal. It is covered with corrosion layers. The lower part of the sample corresponds to the cut metal with no corrosion products.
<b>Alloy</b>	Leaded Bronze
<b>Technology</b>	Cast and cold worked (with final annealing?)
<b>Lab number of sample</b>	None
<b>Sample location</b>	HE-Arc CR, Neuchâtel, Neuchâtel
<b>Responsible institution</b>	Bible & Orient Museum, Fribourg, Fribourg
<b>Date and aim of sampling</b>	2014, metallography and chemical analyses

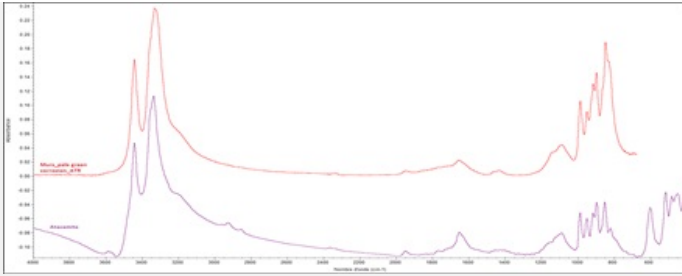
The remaining metal seems to have developed intergranular corrosion at the interface metal / corrosion layer (Fig. 10) slightly enriched in Sn (Fig. 12). The outer green corrosion product (CP2) is matte, powdery and mixed with sediments. It looks regular on Figs. 10 and 11 (around 50μm). This corrosion layer is mainly composed of lead (and/or sulphur), oxygen, silicon, chlorine and is depleted in Cu (Fig. 12 and table 2) except in its top part (CP1) where it is Cl, Cu and O-rich (Fig. 12 and table 2). FTIR seems to indicate that it is constituted of atacamite ( $\text{Cu}_2\text{Cl}(\text{OH})_3$ , Fig. 13). This is confirmed on the EDS spectra of figure 14 where Pb is clearly detected. The inner black corrosion product (CP3) is a dark brown, matte layer (Figs. 2 and 11). It covers all the surface of the object, and forms a very thin layer. It is sulphur and oxygen-rich (Fig. 15). FTIR analysis could not reveal the presence of a specific corrosion product.

Fig. 13: FTIR spectrum (ATR mode) of the green corrosion powder and comparison to atacamite (purple) spectrum. Method of analysis: FTIR spectroscopy, HE- Arc CR,

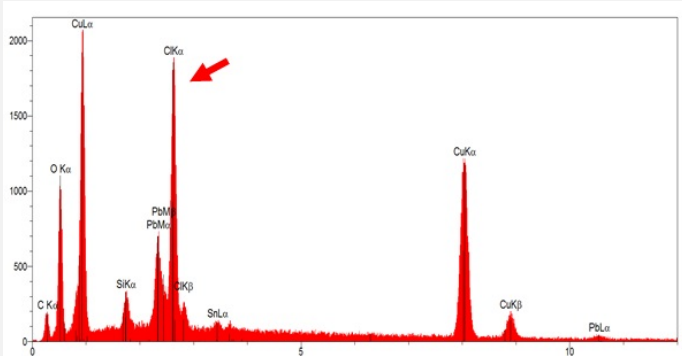
Fig. 14: EDS analysis of the green corrosion powder (Fig. 2). Method of analysis: SEM-EDS, Lab of Electronic Microscopy and Microanalysis, IMA (Néode), HEI Arc,

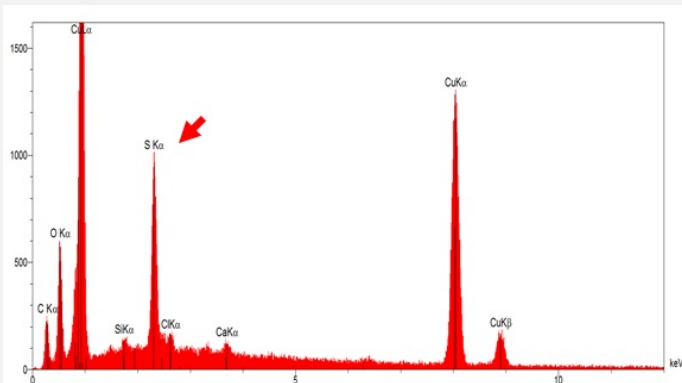
Fig. 15: EDS analysis of the black corrosion powder (Fig. 2). Method of analysis: SEM-EDS, Lab of Electronic Microscopy and Microanalysis, IMA (Néode), HEI Arc,

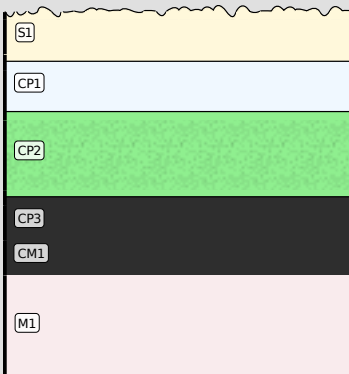
Fig. 5: Stratigraphic representation of the object in cross-section using the MiCorr application. The characteristics of the strata are only accessible by clicking on the drawing that redirects you to the search tool by stratigraphy representation. This representation can be compared to Fig 11, Credit HE-Arc CR.

Based on the analyses carried out, the schematic representation of the stratigraphy of corrosion layers has been corrected: a thin, black sulphur-rich layer covers the metal surface. A thick green layer has developed on top and seems to be constituted mainly of atacamite enriched in lead with sediments on top.
