# HEADREST OR HORSE BIT VFIG 2003.7 - LEADED BRONZE - MODERN TIMES

**Artefact name** Headrest or horse bit VFig 2003.7

**Authors** Christian. Degrigny (HE-Arc CR, Neuchâtel, Neuchâtel, Switzerland) & Valentin. Boissonnas (HE-Arc CR, Neuchâtel, Neuchâtel, Switzerland)

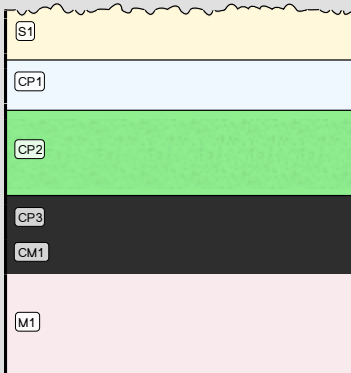
The remaining metal seems to have developed intergranular corrosion at the interface metal / corrosion layer (Fig. 10) slightly enriched in Sn (Fig. 12). The outer green corrosion product (CP2) is matte, powdery and mixed with sediments. It looks regular on Figs. 10 and 11 (around 50μm). This corrosion layer is mainly composed of lead (and/or sulphur), oxygen, silicon, chlorine and is depleted in Cu (Fig. 12 and table 2) except in its top part (CP1) where it is Cl, Cu and O-rich (Fig. 12 and table 2). FTIR seems to indicate that it is constituted of atacamite ( $Cu_2Cl(OH)_3$ , Fig. 13). This is confirmed on the EDS spectra of figure 14 where Pb is clearly detected. The inner black corrosion product (CP3) is a dark brown, matte layer (Figs. 2 and 11). It covers all the surface of the object, and forms a very thin layer. It is sulphur and oxygen-rich (Fig. 15). FTIR analysis could not reveal the presence of a specific corrosion product.

Fig. 5: Stratigraphic representation of the object in cross-section using the MiCorr application. The characteristics of the strata are only accessible by clicking on the drawing that redirects you to the search tool by stratigraphy representation. This representation can be compared to Fig 11, Credit HE-Arc CR.
