CIRCULAR DOOR KNOCKER STRIKING PLATE - CU ALLOY - MODERN TIMES - SWITZERLAND

Artefact name	Circular door knocker striking plate
Authors	Marianne. Senn (EMPA, Dübendorf, Zurich, Switzerland) & Christian. Degrigny (HE-Arc CR, Neuchâtel, Neuchâtel, Switzerland)
Url	/artefacts/437/

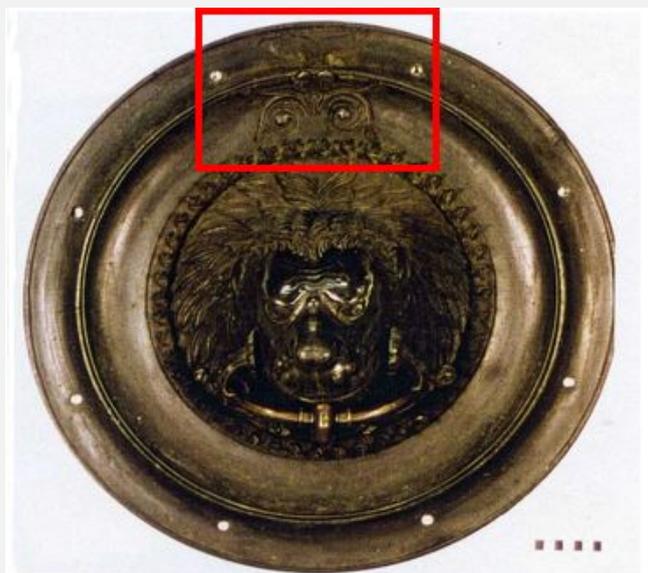
Fig. 2: Possible location of sampling area,

Description of sample	No information is given on where the sample has been taken. A supposed location is however illustrated in Fig. 2. The polished sample shows a well preserved metal surface with some cracks covered by a thin corrosion crust (Fig. 3).
Alloy	Cu Alloy
Technology	Rolled, annealed after cold working
Lab number of sample	MAH 94-156-001
Sample location	Musées d'art et d'histoire, Genève, Geneva
Responsible institution	Musées d'art et d'histoire, Genève, Geneva
Date and aim of sampling	1994, metallography and presence or not of a gilding treatment
