SITULA EMT09-554.665 – TIN BRONZE – IRON AGE – SWITZERLAND

Artefact name	Situla EMT09-554.665
Authors	Christian. Degriigny (HE-Arc CR, Neuchâtel, Neuchâtel, Switzerland) & Marie-Jeanne. Scholl (HE-Arc CR, Neuchâtel, Neuchâtel, Switzerland) & Valentin. Boissonnas (HE-Arc CR, Neuchâtel, Neuchâtel, Switzerland)
Url	/artefacts/458/

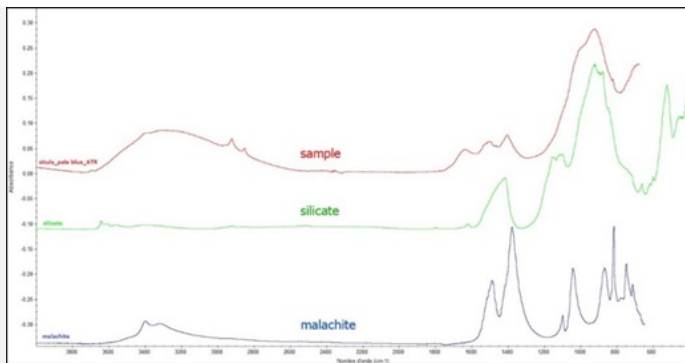
Fig. 14: FTIR spectrum (ATR mode) of the inner blue layer compared to the silicate and malachite standard spectrum. Method of analysis: FTIR spectroscopy, HE- Arc CR,

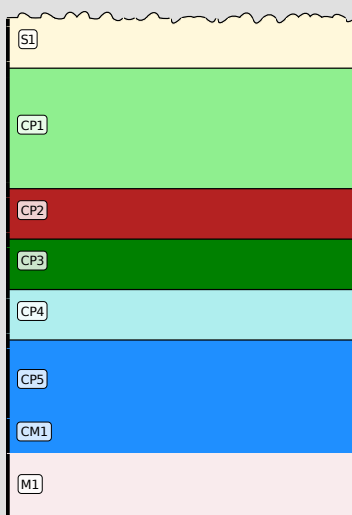
There are 2 stratigraphies (Fig. 5 corresponding to the interior face of the situla and Fig. 6 to its exterior face). The strata are similar in composition but their coding is different: CP1 to CP3 in Fig. 5 correspond to CP3 to CP5 in Fig. 6. Since the stratigraphy of Fig. 6 is more complete, the composition of each of its strata is given below.

The inner layers (CP3-CP5) are Sn and O-rich and depleted in Cu (Table 2). The outer layers (CP1 and CP2) are Cu and O-rich, contain no Sn, and are contaminated with Ca, Si, Al and Fe coming from the soil (Fig. 12). The colour of the corrosion crust varies according to the content of Sn (the more Sn, the darker green or blue the corrosion). FTIR on the inner blue (CP5 and Fig. 14) and outer green (CP1 and Fig. 15) layers were difficult to interpret. Only malachite could be identified in both cases. XRD spectra could not be interpreted because of the deficiency of peaks.

Fig. 6: Stratigraphic representation of the object in cross-section using the MiCorr application. The characteristics of the strata are only accessible by clicking on the drawing that redirects you to the search tool by stratigraphy representation. This representation shows the interior face and can be compared to Fig. 10 (top square), Credit HE-Arc CR, M-J.Scholl.

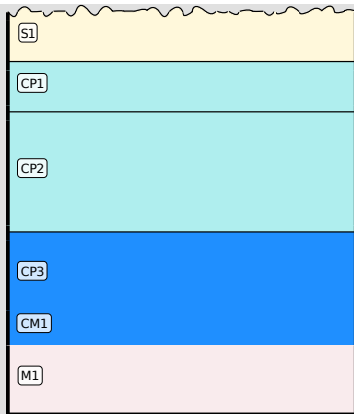
Fig. 5: Stratigraphic representation of the object in cross-section using the MiCorr application. The characteristics of the strata are only accessible by clicking on the drawing that redirects you to the search tool by stratigraphy representation. This representation shows the exterior face and can be compared to Fig. 10 (bottom square), Credit HE-Arc CR, M-J.Scholl.
