SITULA EMT09/554.665 – TIN BRONZE – IRON AGE – SWITZERLAND

Artefact name	Situla EMT09/554.665
Authors	Christian. Degriigny (HE-Arc CR, Neuchâtel, Neuchâtel, Switzerland) & Marie-Jeanne. Scholl (HE-Arc CR, Neuchâtel, Neuchâtel, Switzerland) & Valentin. Boissonnas (HE-Arc CR, Neuchâtel, Neuchâtel, Switzerland)
Url	/artefacts/458/

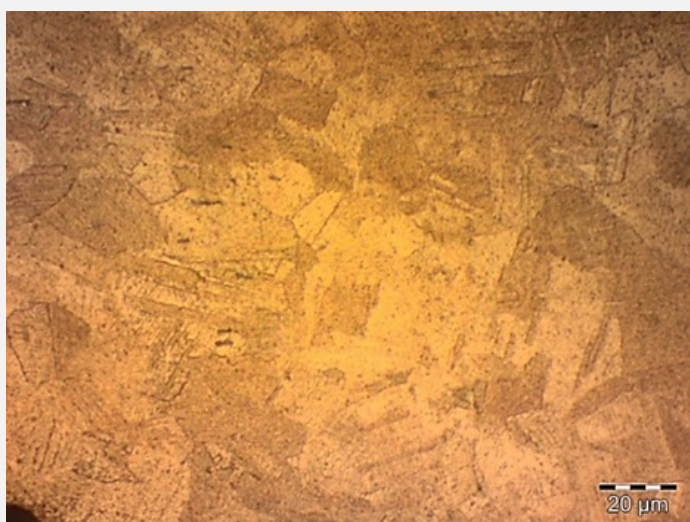
The remaining metal is a dense tin bronze (Fig. 7, Table 1), showing no inclusion. In bright field, the etched alloy shows a structure principally consisting of polygonal alpha phase grains (Fig. 8). Some of the grains include twin lines (Fig. 9). The presence of strain lines (slip lines) indicates a final cold work without annealing (Fig. 9).

Fig. 9: Micrograph of the selected area of Fig. 8, etched, bright field, 500x. The grains show both twin and strain lines,

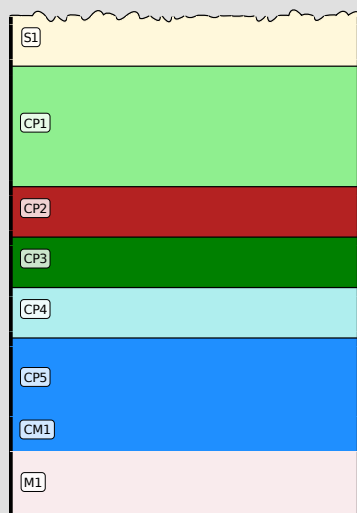
There are 2 stratigraphies (Fig. 5 corresponding to the interior face of the situla and Fig. 6 to its exterior face). The strata are similar in composition but their coding is different: CP1 to CP3 in Fig. 5 correspond to CP3 to CP5 in Fig. 6. Since the stratigraphy of Fig. 6 is more complete, the composition of each of its strata is given below.

The inner layers (CP3-CP5) are Sn and O-rich and depleted in Cu (Table 2). The outer layers (CP1 and CP2) are Cu and O-rich, contain no Sn, and are contaminated with Ca, Si, Al and Fe coming from the soil (Fig. 12). The colour of the corrosion crust varies according to the content of Sn (the more Sn, the darker green or blue the corrosion). FTIR on the inner blue (CP5 and Fig. 14) and outer green (CP1 and Fig. 15) layers were difficult to interpret. Only malachite could be identified in both cases. XRD spectra could not be interpreted because of the deficiency of peaks.

Fig. 6: Stratigraphic representation of the object in cross-section using the MiCorr application. The characteristics of the strata are only accessible by clicking on the drawing that redirects you to the search tool by stratigraphy representation. This representation shows the interior face and can be compared to Fig. 10 (top square), Credit HE-Arc CR, M-J.Scholl.

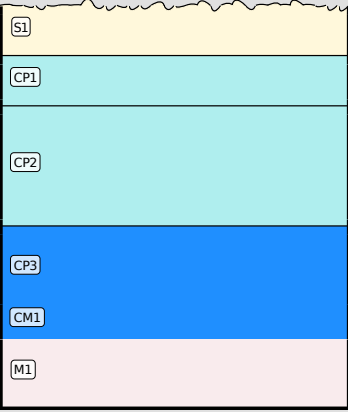
Fig. 5: Stratigraphic representation of the object in cross-section using the MiCorr application. The characteristics of the strata are only accessible by clicking on the drawing that redirects you to the search tool by stratigraphy representation. This representation shows the exterior face and can be compared to Fig. 10 (bottom square), Credit HE-Arc CR, M-J.Scholl.
