# SITULA EMT09-554.665 – TIN BRONZE – IRON AGE – SWITZERLAND

Artefact name	Situla EMT09-554.665
Authors	Christian. Degriigny (HE-Arc CR, Neuchâtel, Neuchâtel, Switzerland) & Marie-Jeanne. Scholl (HE-Arc CR, Neuchâtel, Neuchâtel, Switzerland) & Valentin. Boissonnas (HE-Arc CR, Neuchâtel, Neuchâtel, Switzerland)
Url	/artefacts/459/

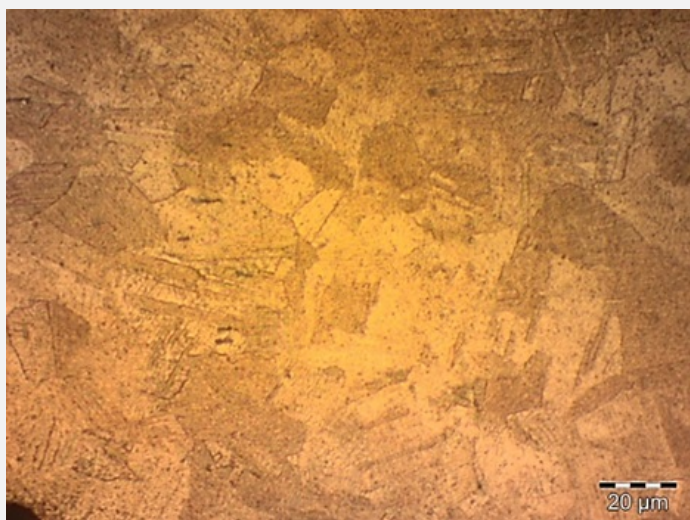
The remaining metal is a dense tin bronze (Fig. 7, Table 1), showing no inclusion. In bright field, the etched alloy shows a structure principally consisting of polygonal alpha phase grains (Fig. 8). Some of the grains include twin lines (Fig. 9). The presence of strain lines (slip lines) indicates a final cold work without annealing (Fig. 9).

Fig. 9: Micrograph of the selected area of Fig. 8, etched, bright field, 500x. The grains show both twin and strain lines,
