SITULA EMT09-554.665 – TIN BRONZE – IRON AGE – SWITZERLAND

Artefact name Situla EMT09-554.665

Authors Christian. Degrigny (HE-Arc CR, Neuchâtel, Neuchâtel, Switzerland) & Marie-Jeanne. Scholl (HE-Arc CR, Neuchâtel, Neuchâtel, Switzerland) & Valentin. Boissonnas (HE-Arc CR, Neuchâtel, Neuchâtel, Switzerland)

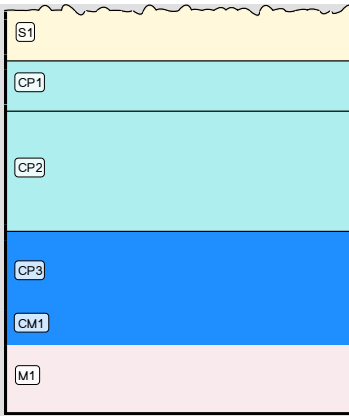
There are 2 stratigraphies (Fig. 5 corresponding to the interior face of the situla and Fig. 6 to its exterior face). The strata are similar in composition but their coding is different: CP1 to CP3 in Fig. 5 correspond to CP3 to CP5 in Fig. 6. Since the stratigraphy of Fig. 6 is more complete, the composition of each of its strata is given below.

Fig. 5: Stratigraphic representation of the object in cross-section using the MiCorr application. The characteristics of the strata are only accessible by clicking on the drawing that redirects you to the search tool by stratigraphy representation. This representation shows the exterior face and can be compared to Fig. 10 (bottom square), Credit HE-Arc CR, M-J.Scholl.
