MILITARY ID TAG 5668-MXX-1008-1 - ZN PB ALLOY - MODERN TIMES - FRANCE

Artefact name	Military ID tag 5668-MXX-1008-1
Authors	Christian. Degryny (HE-Arc CR, Neuchâtel, Neuchâtel, Switzerland) & Marie-Jeanne. Scholl (HE-Arc CR, Neuchâtel, Neuchâtel, Switzerland) & Valentin. Boissonnas (HE-Arc CR, Neuchâtel, Neuchâtel, Switzerland)
Url	/artefacts/464/

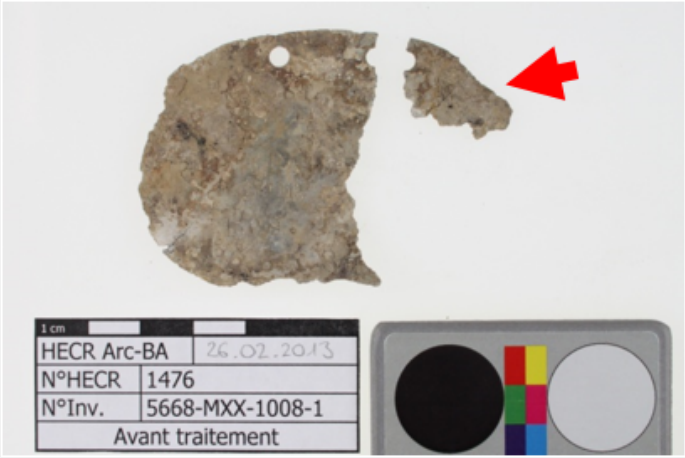
Fig. 2: Location of sample,
