# AIRCRAFT REAR FASTENING PLATE VHS-497 - AL ALLOY - MODERN TIMES

**Artefact name** Aircraft rear fastening plate VHS-497

**Authors** Marianne. Senn (EMPA, Dübendorf, Zurich, Switzerland) & Christian. Degriigny (HE-Arc CR, Neuchâtel, Neuchâtel, Switzerland)

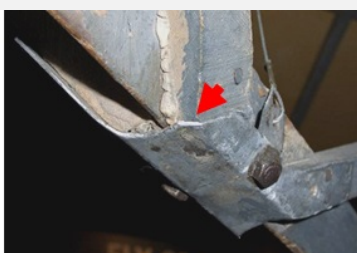
Fig. 1: Photograph of the aeroplane showing the location of the fixation plate (red dot) ([www.hepta.aero](http://www.hepta.aero)),

| <b>Description of the artefact</b> | Fixation plate for the wooden construction at the back of the aeroplane (Fig. 1). |

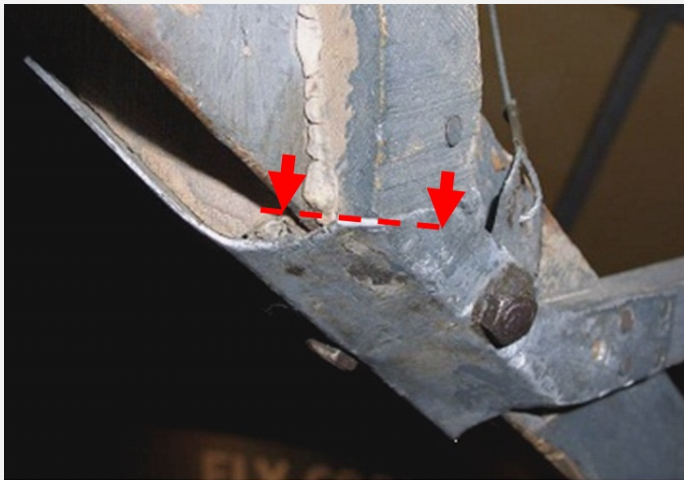
Fig. 2: Location of sampling area,

Sample cut from the corner of the fixation plate (Fig. 2). Dimensions: L = 4mm ; W = 1.2mm.

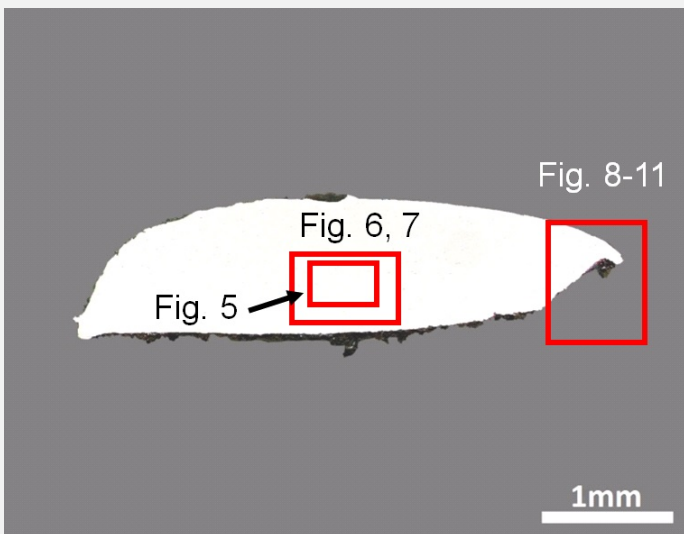
Fig. 3: Micrograph of the cross-section showing the location of Figs. 5 to 11,
