RAIN GUTTER FRAGMENT – GREY CAST IRON – MODERN TIMES – FRANCE

Artefact name Rain gutter fragment

Authors Christian. Degriigny (HE-Arc CR, Neuchâtel, Neuchâtel, Switzerland) & Mathea. Hovind (University of Oslo, Department of archaeology, conservation and history (IAKH-UiO), Oslo, Oslo, Norway)

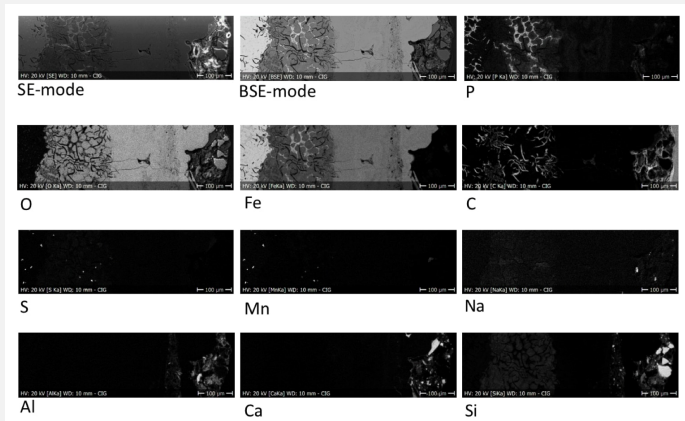
The exterior face (Figs. 2, 4 and 9) consists of a white / light yellow cracked layer (NMM1 in Fig. 5) superimposed by a layer of deposit mixed with orange-red corrosion products (D1 in Fig. 5). Punctual analysis by SEM-EDS (Table 2) revealed that the white / light yellow layer is rich in Ba, O, S, Fe, C and Zn. It has a chemical composition similar to Lithopone (BaSO₄,ZnS), a preparatory paint layer. Fe is probably a contamination from the superimposed porous deposit / corrosion product D1 (Table 2). The latter (D1) is Fe- and O-rich and contains Si, Al and some Ca, in addition to a range of elements (K, P, Na, Cl, S and Ti) present in minor amounts (Table 2). A thin layer of corrosion products (CP1) is located just beneath the paint layer, appearing dark grey under polarized light (Fig. 9). This layer is followed by a corroded metal phase (CM1). Their exact composition was not analyzed but is likely to correspond to the corroded metal phase of the fracture edge, described below.

The interior face (Figs. 2 and 4) shows similar characteristics but does not include a white layer similar to NMM1. The fracture edge however (Figs. 2, 4 and 10), shows a more complex stratigraphy consisting of a dense product layer which can be further divided into two individual strata (CP3 and CP2), superimposed by a porous corrosion crust appearing orange under polarized light (CP1) (Fig. 11). The corroded metal (CM1) is located just beneath CP3 and contains remnants of the P-rich eutectic phase (Figs. 10-12). The M/CP ratio (metal to corrosion products) is rather high, implying extensive internal corrosion. Furthermore, a simple crack is traversing the corrosion layers – indicating a fragilization of the structure. As for the composition of the corrosion products CP1, CP2 and CP3, they all contain Fe and O (Fig. 12). A marbling effect within CP2 and CP3 indicates a variation in the concentration of Fe and O (particularly visible in bright field - Fig. 10). The white deposit (D1 in Fig. 6) might originate from exposure to calcareous water (Table 2). The presence of exogenous elements such as Si, Ca, Al, Na and O (Table 2) was confirmed by elemental mapping (Fig. 12).

Fig. 11: Micrograph similar to Fig. 10 but under polarized light. The external deposit (D1) appears grey-white, CP1 in bright orange, while CP2 and CP3 appear dark red to brown. The corroded metal (CM1) contains remnants of graphite flakes (in white) and the P-rich eutectic (in grey),
