FUNERAL MASK IVC 11595 – CU/AG, WITH SURFACE ENRICHMENT (AG)

Artefact name Funeral mask Ivc 11595

Authors Christian. Degriigny (HE-Arc CR, Neuchâtel, Neuchâtel, Switzerland) & Naima. Gutknecht (HE-Arc CR, Neuchâtel, Neuchâtel, Switzerland) & Valentin. Boissonnas (HE-Arc CR, Neuchâtel, Neuchâtel, Switzerland)

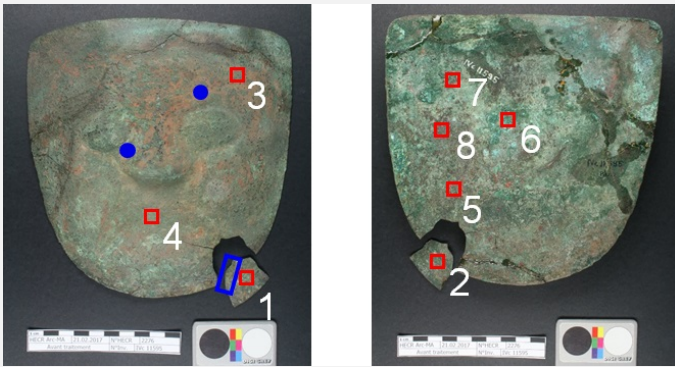
Fig. 2: Front (left) and back (right) faces showing the location of XRF analyses (red squares), sampling areas for SEM-EDS (blue points) and sampling area for examination on cross-section (blue rectangle),

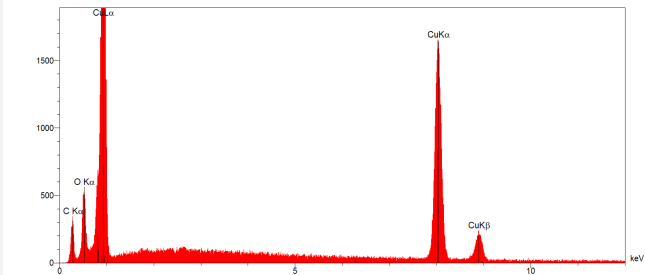
Fig. 10: EDS analysis of the red corrosion layer (Fig. 4). Method of analysis: SEM-EDS, Lab of Electronic Microscopy and Microanalysis, IMA (Néode), HEI Arc,

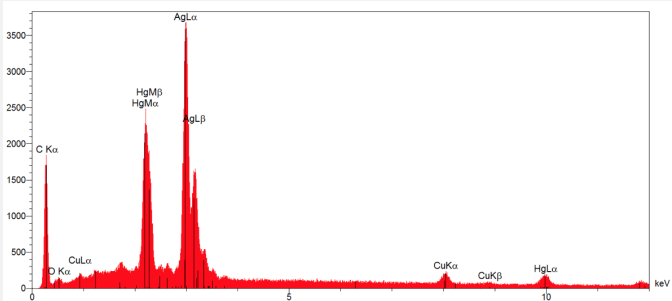
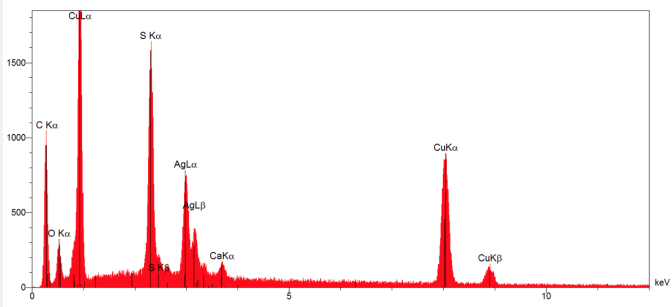
Figs. 11 a and b: EDS analysis of the layer that appears light grey under polarized light, situated below the red layer (Fig. 4). Method of analysis: SEM-EDS, Lab of Electronic Microscopy and Microanalysis, IMA (Néode), HEI Arc,

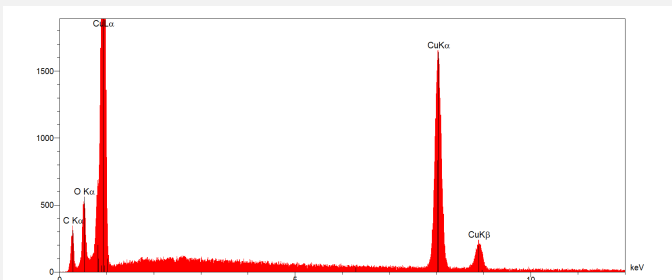
Fig. 12: EDS analysis of the green corrosion layer that has filled the structural void (Fig. 4). Method of analysis: SEM-EDS, Lab of Electronic Microscopy and Microanalysis, IMA (Néode), HEI Arc,

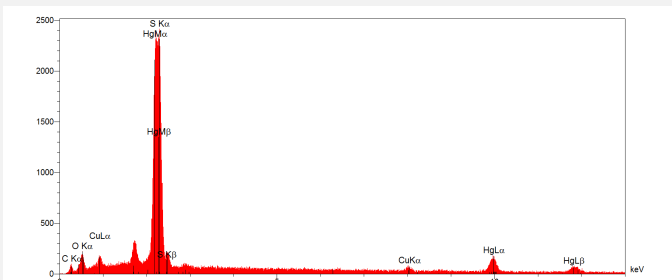
Fig. 13: EDS analysis of the red surface pigment from a surface sample. Method of analysis: SEM-EDS, Lab of Electronic Microscopy and Microanalysis, IMA (Néode), HEI Arc,

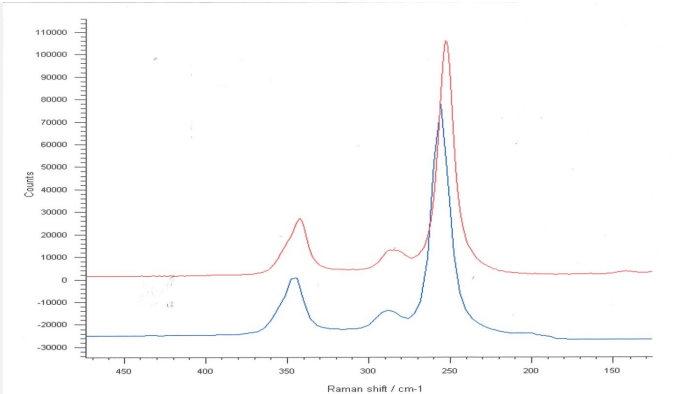
The remaining metal shows a preferential corrosion of copper and a presence of chlorides (Fig. 9, Table 1). There is a preferential corrosion of copper that has fragilized the structure of the sheet metal. The silver enriched surface is entirely covered with copper corrosion products. The outer green layer (CP1) is a copper carbonate (Fig. 12, Table 1), while the red layers (CP2 in Fig. 5a ; CP4 and CP5 in Fig. 5b) are consisting of a copper oxide, most likely cuprite (Fig. 10). Below the cuprite and above the silver enriched surface on the front face a thin black layer is present (appears grey under polarized light). SEM-EDS analysis shows that in that stratum the mercury of the pigment (Fig. 14) has been transformed into a mercury-silver compound (Figs. 8 and 11a and b) which according to Raman spectrometry (Fig. 15) is not cinnabar anymore. In areas this silver- and mercury-rich surface has been pulled off by raising the corrosion layers, leaving structural voids that were subsequently filled by secondary corrosion products, most likely copper carbonates (Figs. 7 and 8). The silver sulphide (HgS, cinnabar, Fig. 14), present as a red pigment on the silver surface, could have been reduced

Fig. 14: Raman analysis of the red pigment on the surface (red line) and the references for cinnabar (blue line). Method of analysis: Raman spectroscopy, HKB,

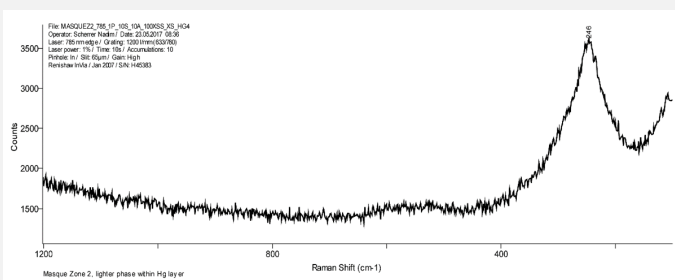
A layer of mercury can be seen with EDS (Figs. 7 and 8). Mercury was not used by the pre-Columbians in metallic form (Scott 2000 and McEwan 2000) but was common as a pigment in form of mercury sulfide (cinnabar).

Fig. 15: Raman analysis of the mercury compounds from the cross section. Method of analysis: Raman spectroscopy, HKB,
