# FUNERAL MASK IVC 11595 – CU/AG, WITH SURFACE ENRICHMENT (AG)

**Artefact name** Funeral mask IVC 11595

**Authors** Christian. Degrigny (HE-Arc CR, Neuchâtel, Neuchâtel, Switzerland) & Naima. Gutknecht (HE-Arc CR, Neuchâtel, Neuchâtel, Switzerland) & Valentin. Boissonnas (HE-Arc CR, Neuchâtel, Neuchâtel, Switzerland)

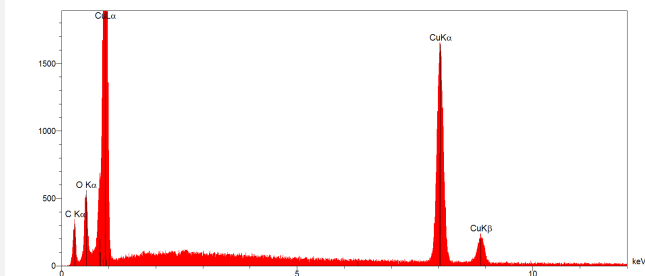
Fig. 10: EDS analysis of the red corrosion layer (Fig. 4). Method of analysis: SEM-EDS, Lab of Electronic Microscopy and Microanalysis, IMA (Néode), HEI Arc,

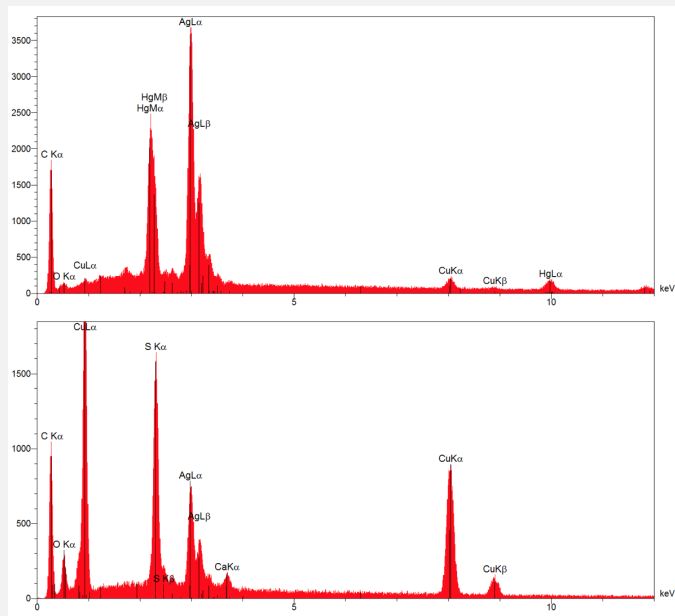
Figs. 11 a and b: EDS analysis of the layer that appears light grey under polarized light, situated below the red layer (Fig. 4). Method of analysis: SEM-EDS, Lab of Electronic Microscopy and Microanalysis, IMA (Néode), HEI Arc,

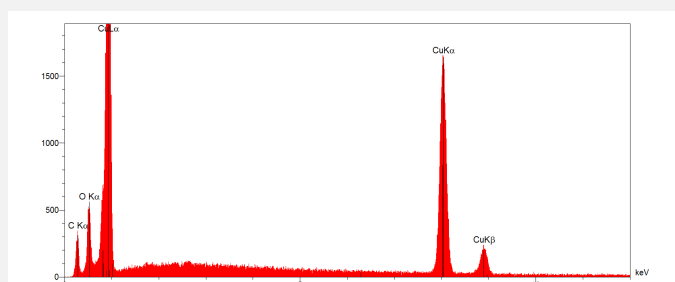
Fig. 12: EDS analysis of the green corrosion layer that has filled the structural void (Fig. 4). Method of analysis: SEM-EDS, Lab of Electronic Microscopy and Microanalysis, IMA (Néode), HEI Arc,

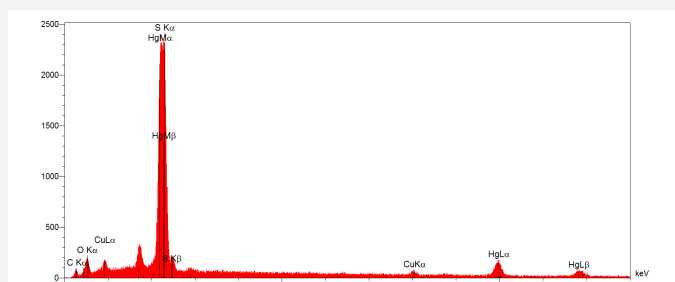
Fig. 13: EDS analysis of the red surface pigment from a surface sample. Method of analysis: SEM-EDS, Lab of Electronic Microscopy and Microanalysis, IMA (Néode), HEI Arc,

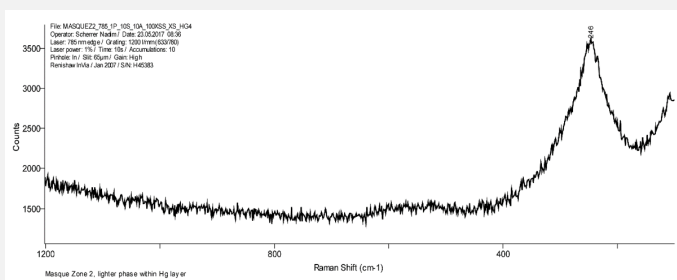
Fig. 15: Raman analysis of the mercury compounds from the cross section. Method of analysis: Raman spectroscopy, HKB,
