FUNERAL MASK IVC 11595 – CU/AG, WITH SURFACE ENRICHMENT (AG)

Artefact name Funeral mask IVC 11595

Authors Christian. Degriy (HE-Arc CR, Neuchâtel, Neuchâtel, Switzerland) & Naima. Gutknecht (HE-Arc CR, Neuchâtel, Neuchâtel, Switzerland) & Valentin. Boissonnas (HE-Arc CR, Neuchâtel, Neuchâtel, Switzerland)

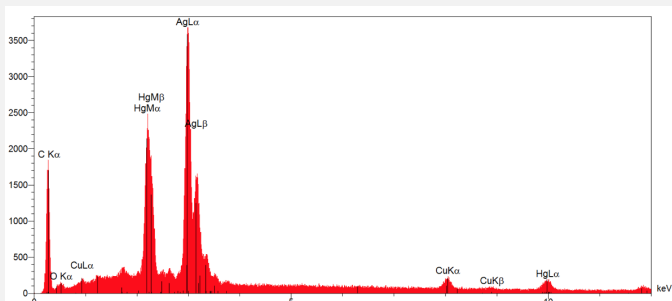
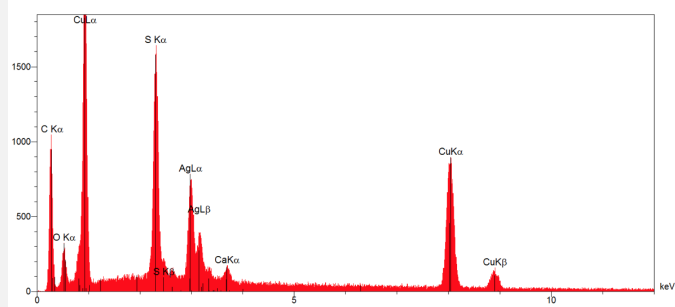
Figs. 11 a and b: EDS analysis of the layer that appears light grey under polarized light, situated below the red layer (Fig. 4). Method of analysis: SEM-EDS, Lab of Electronic Microscopy and Microanalysis, IMA (Néode), HEI Arc,

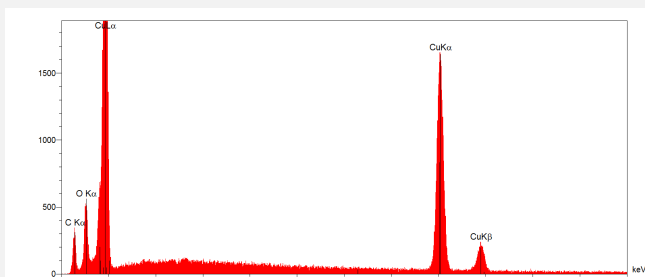
Fig. 12: EDS analysis of the green corrosion layer that has filled the structural void (Fig. 4). Method of analysis: SEM-EDS, Lab of Electronic Microscopy and Microanalysis, IMA (Néode), HEI Arc,

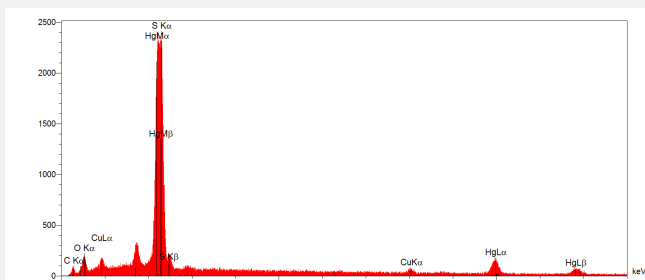
Fig. 13: EDS analysis of the red surface pigment from a surface sample. Method of analysis: SEM-EDS, Lab of Electronic Microscopy and Microanalysis, IMA (Néode), HEI Arc,

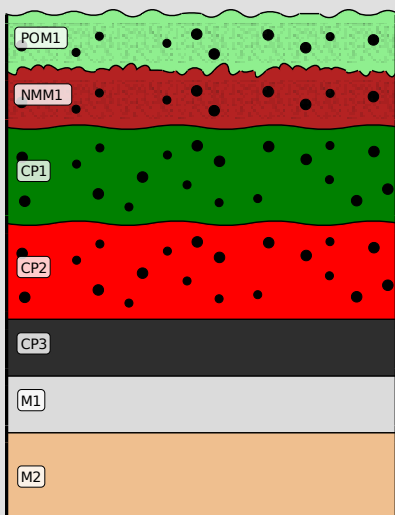
Fig. 5a: Stratigraphic representation of the cross-section from Figs. 3a or 4 (front of the object) using the MiCorr application. The characteristics of the strata are only accessible by clicking on the drawing that redirects you to the search tool by stratigraphy representation, Credit HE-Arc CR, N. Gutknecht.

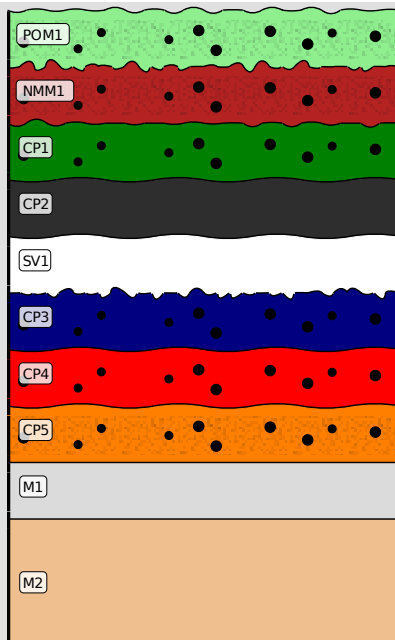
Fig. 5b: Stratigraphic representation of the cross-section from Figs. 3b and 4 (back of the object) using the MiCorr application. CP2 is CP3 while CP3 is CP2 and CP3 is CP4 in Fig. 3b. The characteristics of the strata are only accessible by clicking on the drawing that redirects you to the search tool by stratigraphy representation, Credit HE-Arc CR, N. Gutknecht.
