VOTIVE FIGURE OF A BAT IVB4168 – GILDED BRASS – MODERN TIMES

Artefact name Votive figure of a bat IVb4168

Authors Christian. Degriigny (HE-Arc CR, Neuchâtel, Neuchâtel, Switzerland) & Naima. Gutknecht (HE-Arc CR, Neuchâtel, Neuchâtel, Switzerland) & Valentin. Boissonnas (HE-Arc CR, Neuchâtel, Neuchâtel, Switzerland)

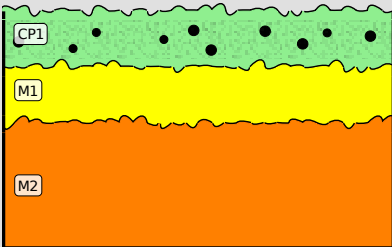
Fig 5: Stratigraphic representation 1 from Fig. 4 using the MiCorr application. The characteristics of the strata are only accessible by clicking on the drawing that redirects you to the search tool by stratigraphy representation, Credit HE-Arc CR, N.Gutknecht.

The metal seems to have been heavily attacked (acid dissolution). There are several perforations on the lower part of the object, and where the gold layer is absent the surface is unevenly pitted by corrosion (Figs. 1, 2 and 7). The submetallic core is not visible from the surface.

There are two corrosion products (Figs. 7 and 8). The red one (CP2) has a submetallic brightness and is opaque, non-magnetic, compact, hard and adherent. It is very thin (less than a few microns thick) and only appears where the gold layer has been lost. The EDX spectrum (Fig. 9) shows that it is a Cu- and O rich product, probably cuprite (Cu_2O). The light green to white corrosion product (CP1) has a waxy consistency and is thin, translucent, non-magnetic, powdery and very soft. It is very loosely bound. It is distributed on the whole object (front and back) as disparate clumps. It is mainly located on the cavities and irregularities of the surface. FTIR analyses (ATR mode) of both green and white areas of CP1 have similar spectra and were identified as copper nitrate (Fig. 10).

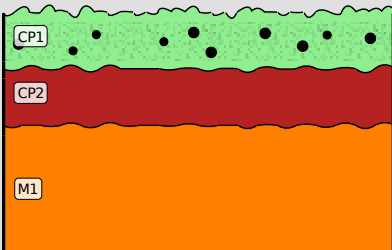
Fig. 6: Stratigraphic representation 2 from Fig. 4 using the MiCorr application. The characteristics of the strata are only accessible by clicking on the drawing that redirects you to the search tool by stratigraphy representation, Credit HE-Arc CR, N.Gutknecht.
