# VOTIVE FIGURE OF A BAT IVB4168 - GILDED BRASS - MODERN TIMES

Votive figure of a bat IVb4168

Christian. Degrigny (HE-Arc CR, Neuchâtel, Neuchâtel, Switzerland) & Naima. Gutknecht (HE-Arc CR, Neuchâtel, Neuchâtel, Switzerland) & Valentin. Boissonnas (HE-Arc CR, Neuchâtel, Neuchâtel, Switzerland)

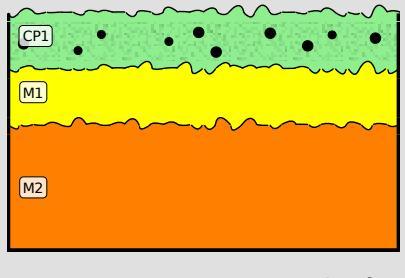
Fig 5: Stratigraphic representation 1 from Fig. 4 using the MiCorr application. The characteristics of the strata are only accessible by clicking on the drawing that redirects you to the search tool by stratigraphy representation, Credit HE-Arc CR, N.Gutknecht.

The metal seems to have been heavily attacked (acid dissolution). There are several perforations on the lower part of the object, and where the gold layer is absent the surface is unevenly pitted by corrosion (Figs. 1, 2 and 7). The submetallic core is not visible from the surface.

There are two corrosion products (Figs. 7 and 8). The red one (CP2) has a submetallic brightness and is opaque, nonmagnetic, compact, hard and adherent. It is very thin (less than a few microns thick) and only appears where the gold layer has been lost. The EDX spectrum (Fig. 9) shows that it is a Cu- and O rich product, probably cuprite (Cu2O). The light green to white corrosion product (CP1) has a waxy consistency and is thin, translucent, non-magnetic, powdery and very soft. It is very loosely bound. It is distributed on the whole object (front and back) as disparate clumps. It is mainly located on the cavities and irregularities of the surface. FTIR analyses (ATR mode) of both green and white areas of CP1 have similar spectra and were identified as copper nitrate (Fig. 10).

The dissolution of the metal and the subsequent formation of the patina is most likely the result of a forced attack with concentrated nitric acid. The holes and pits in the metal are unnatural for a natural corrosion process which would produce a stratified, adherent and thick corrosion crust (Craddock 2009). The copper nitrates could have formed over time from residual acidic solution that was left on the surface.The lack of an archaeological context, the

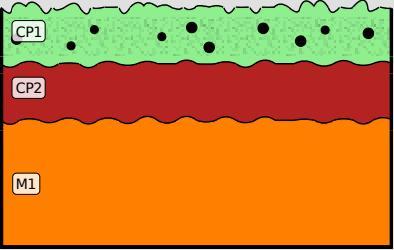
Fig. 6: Stratigraphic representation 2 from Fig. 4 using the MiCorr application. The characteristics of the strata are only accessible by clicking on the drawing that redirects you to the search tool by stratigraphy representation, Credit HE-Arc CR, N.Gutknecht.
