FRAGMENT OF AN AEGIS OF NEÏTH 1886.305.0096 – LEADED BRONZE

Artefact name Fragment of an Aegis of Neïth 1886.305.0096

Authors Line. Pedersen (HE-Arc, Neuchâtel, Neuchâtel, Switzerland) & Christian. Degrigny (HE-Arc CR, Neuchâtel, Neuchâtel, Switzerland) & Valentin. Boissonnas (HE-Arc CR, Neuchâtel, Neuchâtel, Switzerland)

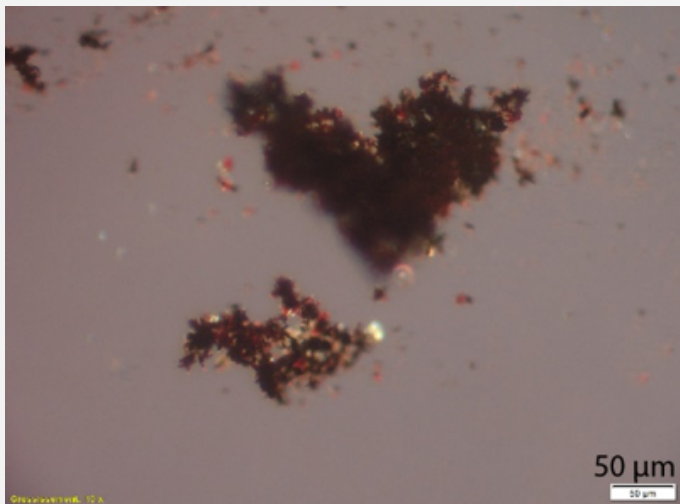
Fig. 19: Observation of the red corrosion product above the black original surface containing corresponding markers such as engravings,
