# CORRODED METAL SHEET FN 655.13.01 – FE ALLOY – MODERN TIMES – SWITZERLAND

<b>Artefact name</b>	Corroded metal sheet FN 655.13.01
<b>Authors</b>	Marianne. Senn (EMPA, Dübendorf, Zurich, Switzerland) & Christian. Degrigny (HE-Arc CR, Neuchâtel, Neuchâtel, Switzerland)
<b>Url</b>	/artefacts/529/

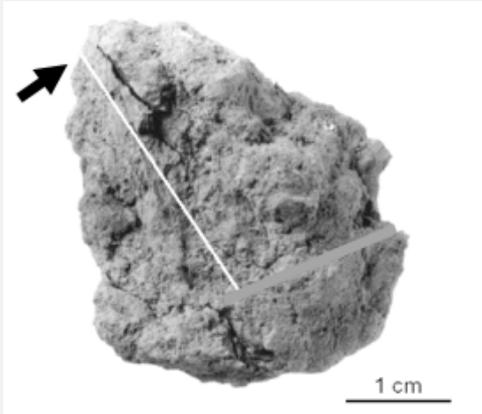
Fig. 2: Location of sampling area,

<b>Description of sample</b>	A longitudinal cut has been made through the sheet (Fig. 2). Large parts of the corrosion crust fell off during sampling (Fig. 3).
<b>Alloy</b>	Fe Alloy
<b>Technology</b>	Forged with final cold work
<b>Lab number of sample</b>	NEF 655
<b>Sample location</b>	Empa (Marianne Senn)
<b>Responsible institution</b>	Kantonsarchäologie, Dübendorf, Zurich
<b>Date and aim of sampling</b>	2000, metallography
