# MILITARY ID TAG 5668-MXX-1008-1 - ZN PB ALLOY - MODERN TIMES - FRANCE

<b>Artefact name</b>	Military ID tag 5668-MXX-1008-1
<b>Authors</b>	Christian. Degryny (HE-Arc CR, Neuchâtel, Neuchâtel, Switzerland) & Marie-Jeanne. Scholl (HE-Arc CR, Neuchâtel, Neuchâtel, Switzerland) & Valentin. Boissonnas (HE-Arc CR, Neuchâtel, Neuchâtel, Switzerland)
<b>Url</b>	/artefacts/537/

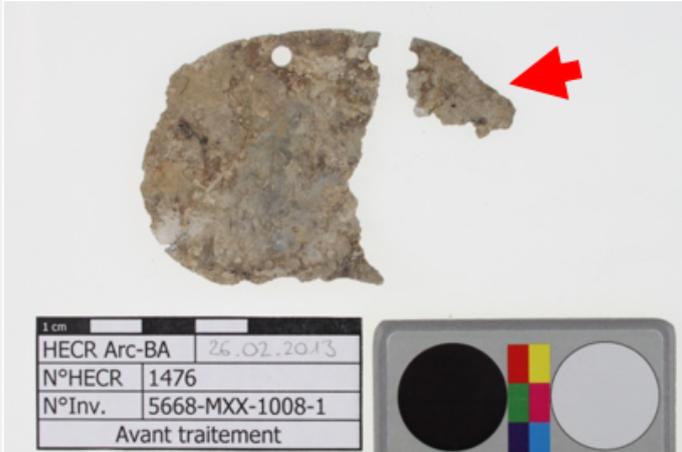
Fig. 2: Location of sample,

<b>Description of sample</b>	This sample was cut out of fragment b in Fig. 1. The cross-section shows the entire thickness of the plate (L = 8 mm, W= 1 mm). The corrosion goes through the whole metal thickness but a metallic core remains (Figs. 4 and 7).
<b>Alloy</b>	Zn Pb Alloy
<b>Technology</b>	Cold worked (laminated)
<b>Lab number of sample</b>	None
<b>Sample location</b>	HE-Arc CR, Neuchâtel, Neuchâtel
<b>Responsible institution</b>	Pôle d'Archéologie Interdépartemental Rhénan, Sélestat, Alsace
<b>Date and aim of sampling</b>	2013, metallography and chemical analyses
