SITULA EMT09-554.665 – TIN BRONZE – IRON AGE – SWITZERLAND

Artefact name	Situla EMT09-554.665
Authors	Christian. Degriigny (HE-Arc CR, Neuchâtel, Neuchâtel, Switzerland) & Marie-Jeanne. Scholl (HE-Arc CR, Neuchâtel, Neuchâtel, Switzerland) & Valentin. Boissonnas (HE-Arc CR, Neuchâtel, Neuchâtel, Switzerland)
Url	/artefacts/538/

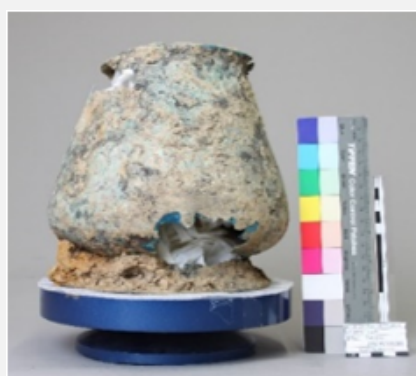
Fig. 1: Situla (Archeodunum (Gollion), 2009) inverted as found in situ,

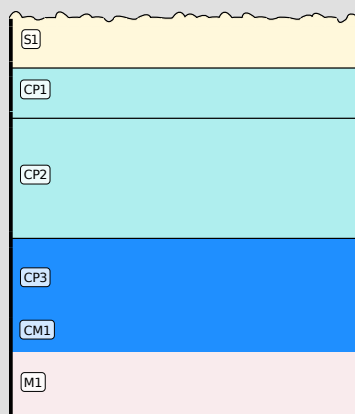
There are 2 stratigraphies (Fig. 5 corresponding to the interior face of the situla and Fig. 6 to its exterior face). The strata are similar in composition but their coding is different: CP1 to CP3 in Fig. 5 correspond to CP3 to CP5 in Fig. 6. Since the stratigraphy of Fig. 6 is more complete, the composition of each of its strata is given below.

Fig. 5: Stratigraphic representation of the sample taken from the detached fragment of the situla in cross-section using the MiCorr application. The characteristics of the strata are only accessible by clicking on the drawing that redirects you to the search tool by stratigraphy representation. This representation shows the exterior face and can be compared to Fig. 10 (bottom red rectangle), Credit HE-Arc CR, M-J.Scholl.

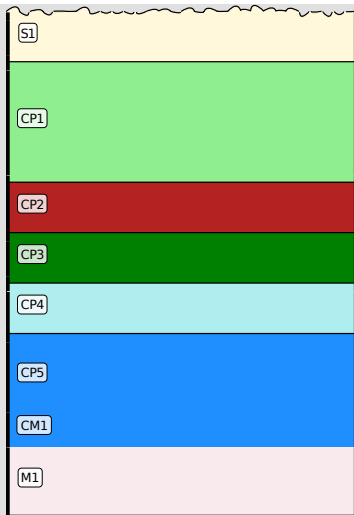
The inner layers (CP3-CP5) are Sn and O-rich and depleted in Cu (Table 2). The outer layers (CP1 and CP2) are Cu and O-rich, contain no Sn, and are contaminated with Ca, Si, Al and Fe coming from the soil (Fig. 12). The colour of the corrosion crust varies according to the content of Sn (the more Sn, the darker green or blue the corrosion). FTIR on the inner blue (CP5 and Fig. 14) and outer green (CP1 and Fig. 15) layers were difficult to interpret. Only malachite could be identified in both cases. XRD spectra could not be interpreted because of the deficiency of peaks.

Fig. 6: Stratigraphic representation of the sample taken from the detached fragment of the situla in cross-section using the MiCorr application. The characteristics of the strata are only accessible by clicking on the drawing that redirects you to the search tool by stratigraphy representation. This representation shows the interior face and can be compared to Fig. 10 (top red rectangle), Credit HE-Arc CR, M-J.Scholl.
