## SITULA EMT09-554.665 – TIN BRONZE – IRON AGE – SWITZERLAND

<b>Artefact name</b>	Situla EMT09-554.665
<b>Authors</b>	Christian. Degriigny (HE-Arc CR, Neuchâtel, Neuchâtel, Switzerland) & Marie-Jeanne. Scholl (HE-Arc CR, Neuchâtel, Neuchâtel, Switzerland) & Valentin. Boissonnas (HE-Arc CR, Neuchâtel, Neuchâtel, Switzerland)
<b>Url</b>	/artefacts/538/

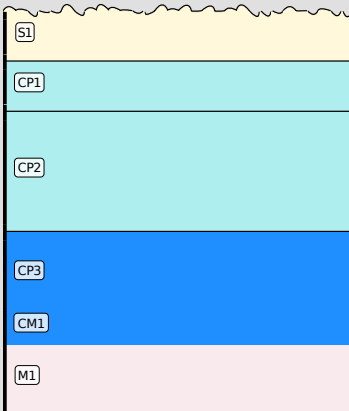
There are 2 stratigraphies (Fig. 5 corresponding to the interior face of the situla and Fig. 6 to its exterior face). The strata are similar in composition but their coding is different: CP1 to CP3 in Fig. 5 correspond to CP3 to CP5 in Fig. 6. Since the stratigraphy of Fig. 6 is more complete, the composition of each of its strata is given below.

Fig. 5: Stratigraphic representation of the sample taken from the detached fragment of the situla in cross-section using the MiCorr application. The characteristics of the strata are only accessible by clicking on the drawing that redirects you to the search tool by stratigraphy representation. This representation shows the exterior face and can be compared to Fig. 10 (bottom red rectangle), Credit HE-Arc CR, M-J.Scholl.

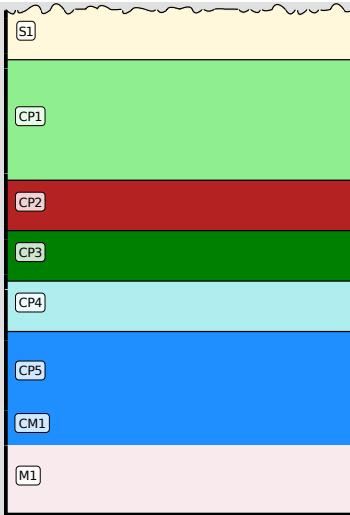
Fig. 6: Stratigraphic representation of the sample taken from the detached fragment of the situla in cross-section using the MiCorr application. The characteristics of the strata are only accessible by clicking on the drawing that redirects you to the search tool by stratigraphy representation. This representation shows the interior face and can be compared to Fig. 10 (top red rectangle), Credit HE-Arc CR, M-J.Scholl.
