SITULA EMT09/554.665 – TIN BRONZE – IRON AGE – SWITZERLAND

Artefact name	Situla EMT09/554.665
Authors	Christian. Degriigny (HE-Arc CR, Neuchâtel, Neuchâtel, Switzerland) & Marie-Jeanne. Scholl (HE-Arc CR, Neuchâtel, Neuchâtel, Switzerland) & Valentin. Boissonnas (HE-Arc CR, Neuchâtel, Neuchâtel, Switzerland)
Url	/artefacts/538/

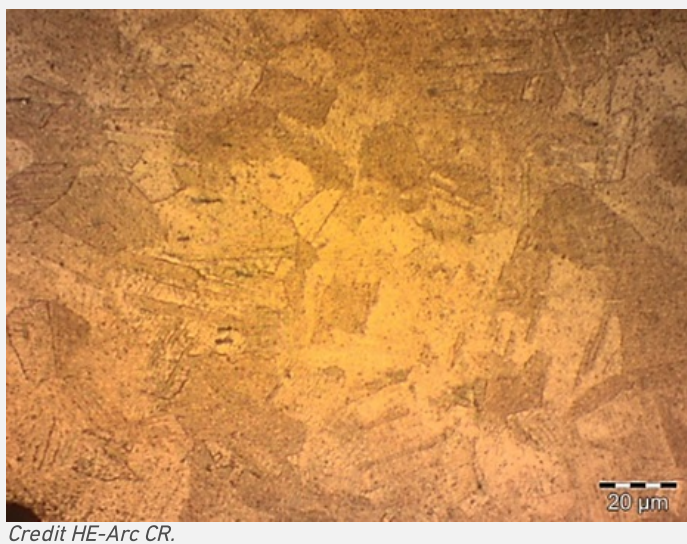
The remaining metal is a dense tin bronze (Fig. 7, Table 1), showing no inclusion. In bright field, the etched alloy shows a structure principally consisting of polygonal alpha phase grains (Fig. 8). Some of the grains include twin lines (Fig. 9). The presence of strain lines (slip lines) indicates a final cold work without annealing (Fig. 9).

Fig. 9: Micrograph of the selected area of Fig. 8, etched, bright field, 500x. The grains show both twin and strain lines,
