FRAGMENT OF AN AEGIS OF NEÏTH 1886.305.0096 – LEADED BRONZE

Artefact name Fragment of an Aegis of Neïth 1886.305.0096

Authors Line. Pedersen (HE-Arc, Neuchâtel, Neuchâtel, Switzerland) & Christian. Degrigny (HE-Arc CR, Neuchâtel, Neuchâtel, Switzerland) & Valentin. Boissonnas (HE-Arc CR, Neuchâtel, Neuchâtel, Switzerland)

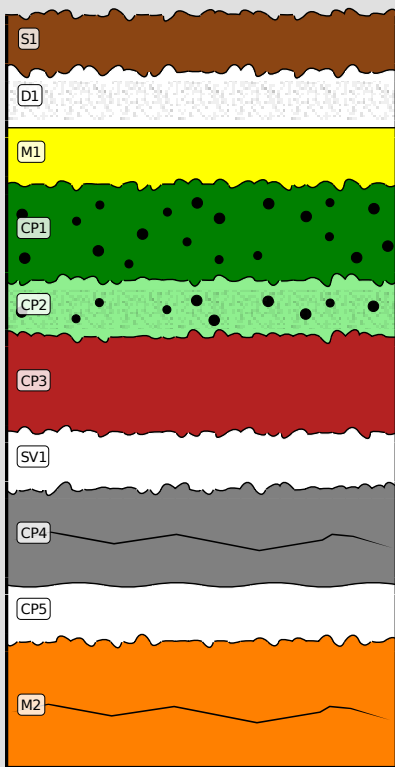
Fig.9: Schematic representation combining stratigraphies 1 and 2 using the MiCorr application. The characteristics of the strata are only accessible by clicking on the drawing that redirects you to the search tool by stratigraphy representation, Credit He-Arc CR, L.Pedersen.

As indicated by the X-ray tomography, the metal of the aegis seems to be well preserved (Figs. 11-12). The metal (M2 in Fig.9 and M1 in Fig. 10) was analysed on the broken edge of the bottom of the artefact where despite a highly corroded surface, the metal seems to be the best preserved. The XRF analyses revealed that the metal is a leaded bronze with remains of gold leaf on the surface (Table 1, Au was detected in the measurement spots 4,5 and 6) (Scott 2002; Gouda 2012; Mohammed 2012).

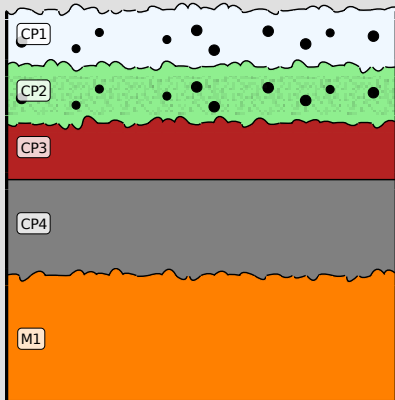
Fig.10: Schematic representation of stratigraphy 3 using the MiCorr application. CP1 is CP6 in Fig. 8. The characteristics of the strata are only accessible by clicking on the drawing that redirects you to the search tool by stratigraphy representation, Credit He-Arc CR, L. Pedersen.

and waxy corrosion product close to the original surface. This observation and the presence of high amounts of copper oxychlorides led us to identify this white corrosion product as nantokite (CuCl). The localized light blue corrosion product (CP6 in Fig. 8, CP1 in Fig. 10) present in one area on the back (Figs. 17-18) was identified as chalconatronite ($\text{Na}_2\text{Cu}(\text{CO}_3)_2 \cdot 3\text{H}_2\text{O}$) (Fig. 23). The red corrosion layer (CP3) below the copper oxychlorides and above the dark black original surface (Figs. 19-20) was identified as a mixture of cuprite (Cu_2O) as major compound and tenorite (CuO) as minor compound (Fig. 24). It is possible that the tenorite was a contamination from the black surface below the cuprite layer.
