ARMATURE FROM A CLOCK MOVEMENT MIH IV-212 – ZN AL SN CU ALLOY – MODERN TIMES

Artefact name	Armature from a clock movement MIH IV-212
Authors	Marianne. Senn (EMPA, Dübendorf, Zurich, Switzerland) & Christian. Degriigny (HE-Arc CR, Neuchâtel, Neuchâtel, Switzerland)
Url	/artefacts/597/

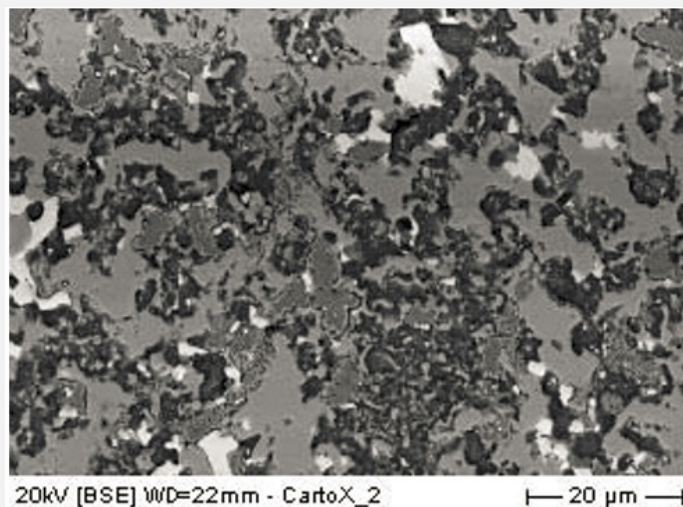
The Zn-rich phase is heavily oxidised internally (Fig. 7). The corrosion has developed throughout the entire metal body, generating cracks (Figs. 8 and 9). The cracks are Zn, O and C-rich (Fig. 10) and could be composed of zinc carbonate.

Corrosion form	Internal cracking
Corrosion type	zinc pest

The armature of the clock mechanism is constituted of a ZnAlSnCu alloy. The absence of cohesion between the different phases has led to the penetration of O during the manufacturing of the alloy. Small original cracks have developed further eventually causing the armature to break. This phenomenon, known since the 1920's, is called zinc pest. It develops mainly on cast objects, starting with localised modifications (blisters and pits, Cramer and Covino 2005).
