SHOE NAIL 2637 1370.B. – HYPOEUTECTOID STEEL – ROMAN TIMES – SWITZERLAND

Artefact name	Shoe nail 2637 1370.B.
Authors	Christian. Degriigny (HE-Arc CR, Neuchâtel, Neuchâtel, Switzerland) & Valentin. Boissonnas (HE-Arc CR, Neuchâtel, Neuchâtel, Switzerland) & Vincent Chappuis. (HE-Arc CR, Neuchâtel, Neuchâtel, Switzerland)
Url	/artefacts/598/

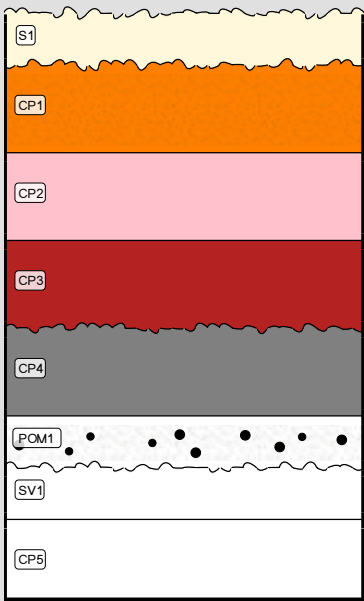
Si, Al, P and K can be considered external markers, helping to determine the limit of the original surface (Fig. 13 and Table 1). The outer layer of corrosion products (CP1-3) ranges from dark grey to orange in bright field and contains less O and Fe on its borders than the inner layer (CP4-5, Figs. 4 and 13, Table 1). The SEM pictures show a marbling appearance of the inner corrosion layer (CP5). Cl and S do not seem to be present in the sampled nail.

Fig. 13: Elemental chemical distribution of the selected area from Fig. 4 (90° counter-clockwise rotated). SEM-EDS,

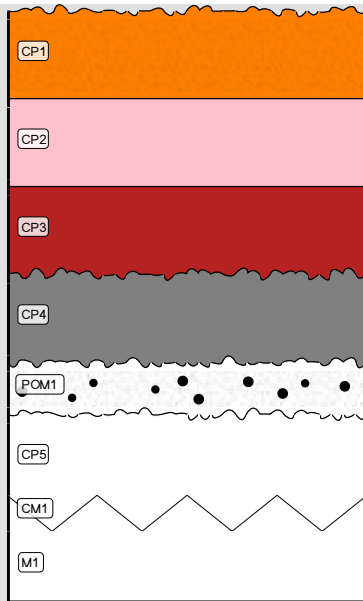
Fig. 6: Stratigraphic representation of the nail in cross-section using the MiCorr application. The characteristics of the strata are only accessible by clicking on the drawing that redirects you to the search tool by stratigraphy representation. This representation can be compared to Fig. 14, Credit HE-Arc CR, V.Chappuis.
