SITULA EMT09-554.665 – TIN BRONZE – IRON AGE – SWITZERLAND

Artefact name	Situla EMT09-554.665
Authors	Christian. Degriigny (HE-Arc CR, Neuchâtel, Neuchâtel, Switzerland) & Marie-Jeanne. Scholl (HE-Arc CR, Neuchâtel, Neuchâtel, Switzerland) & Valentin. Boissonnas (HE-Arc CR, Neuchâtel, Neuchâtel, Switzerland)
Url	/artefacts/601/

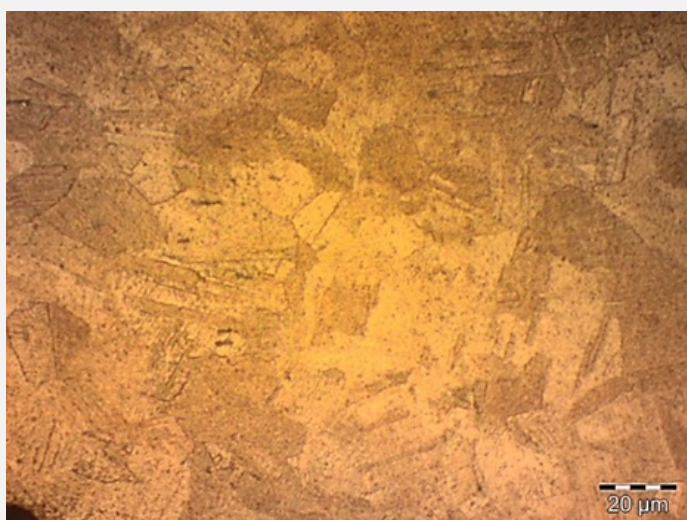
The remaining metal is a dense tin bronze (Fig. 7, Table 1), showing no inclusion. In bright field, the etched alloy shows a structure principally consisting of polygonal alpha phase grains (Fig. 8). Some of the grains include twin lines (Fig. 9). The presence of strain lines (slip lines) indicates a final cold work without annealing (Fig. 9).

Fig. 9: Micrograph of the selected area of Fig. 8, etched, bright field, 500x. The grains show both twin and strain lines,

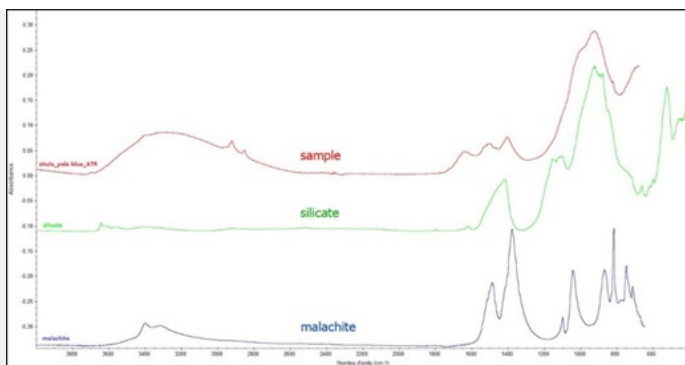
Fig. 14: FTIR spectrum (ATR mode) of the inner blue layer compared to the silicate and malachite standard spectrum. Method of analysis: FTIR spectroscopy, HE- Arc CR,
