BUGATTI COOLING SYSTEM PIPE – AL ALLOY – FRANCE

Artefact name Bugatti cooling system pipe

Authors Granget. Elodie (, None) & . (MNAM (Musée National de l'Automobile de Mulhouse), Mulhouse, Alsace, France)

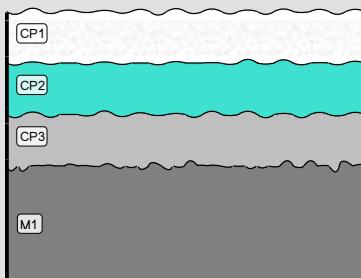
The stratum M is an aluminium alloy. Three CP strata have been identified. CP3 has a greyish mate color and is covering all of the corroded side of the pipe. Scattered over this uniform layer, blue-green (CP2) and white (CP1) spots of corrosion products can be found.

Fig. 5: Stratigraphic representation of the Bugatti water pipe under binocular using the MiCorr application. The characteristics of the strata are only accessible by clicking on the drawing that redirects you to the search tool by stratigraphy representation. This representation can be compared to Fig. 4, Credit HE-Arc CR, E.Granget.

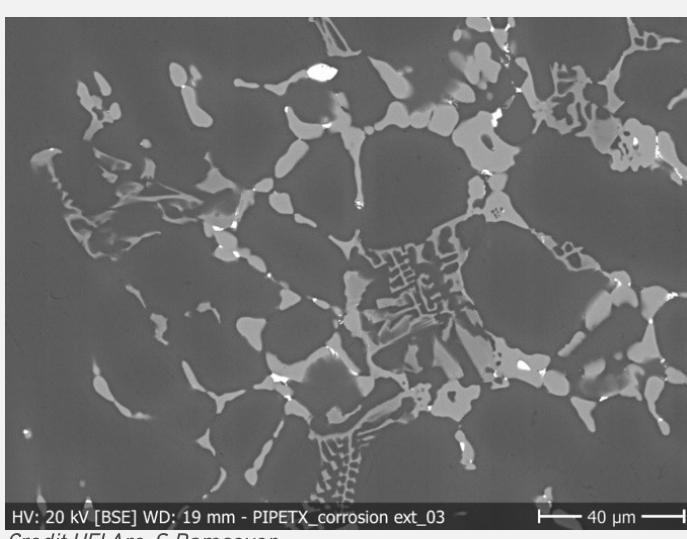
Point analyses of the main dendritic phase showed that it is made of Al, Cu and Zn (Table 1 and Fig. 11). Elemental chemical distribution with EDS allowed to identified the following repartition (Fig. 12): Zn is uniformly present in the alloy. There are two interdendritic phases (Fig. 13): a eutectic phase containing Fe and Cu, and a second phase containing mostly Cu. Additionally Sn and Si precipitates could be identified.

Fig. 11: Close-up image of Fig. 10,

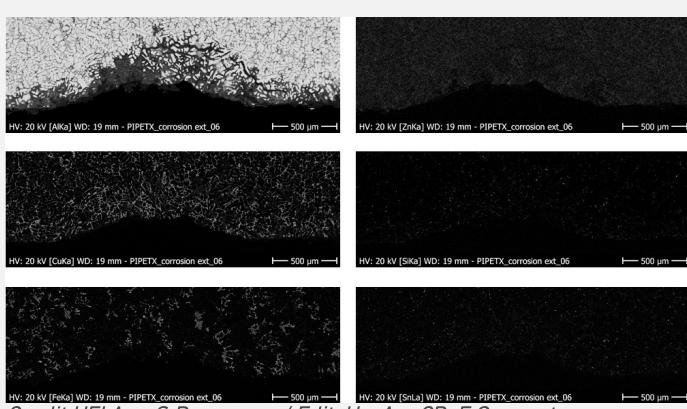
Fig. 12: SEM image and EDS elemental chemical distribution of main and interdendritic phases of the pipe. 20kV,

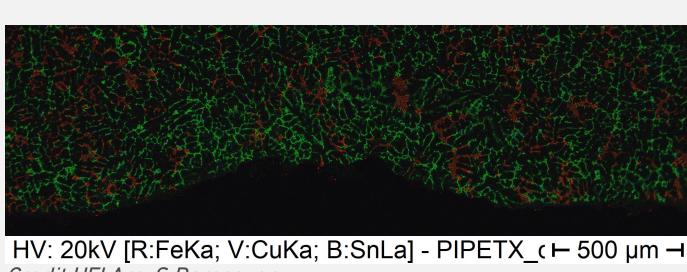
Fig. 13: Fe (red), Cu (green) and Sn (blue) chemical distribution of the area of Fig. 9. Method of analysis: SEM-EDS. Lab. of Electronic Microscopy and Microanalysis, Néode, HEI Arc,
