BUGATTI COOLING SYSTEM PIPE – AL ALLOY – FRANCE

Artefact name	Bugatti cooling system pipe
Authors	Granget. Elodie (, None) & . (MNAM (Musée National de l'Automobile de Mulhouse), Mulhouse, Alsace, France)
Url	/artefacts/670/

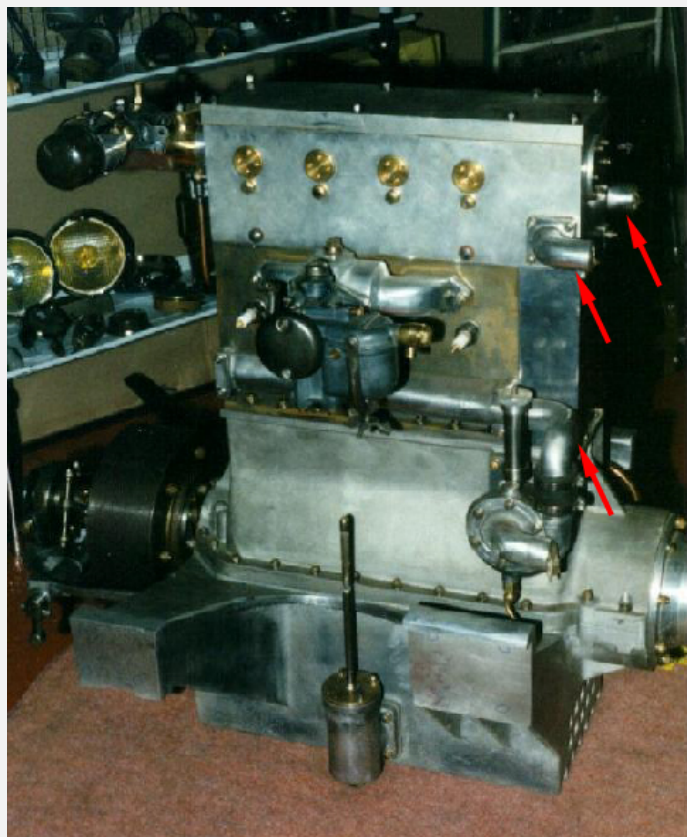
Fig. 2: Examples of water pipes located on a Type 37 engine,

A combustion engine transforms thermal energy into kinetic energy. This process is imperfect and releases a lot of heat through the block of the engine. Therefore, these parts need to be cooled down. A cooling system circulating water between the block [hot] and a heat exchanger (or radiator) [cold] is frequently used to fulfill this function (Poulain, 1995, p.86). Most of the time, the Bugatti inline cylinder engines have aluminium water pipes entering the block from below and exiting it from above, as shown on Fig.2.

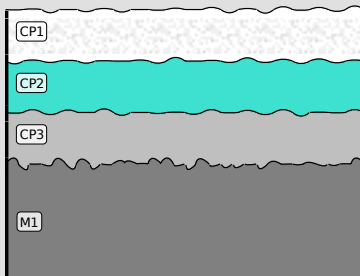
The schematic representation below gives an overview of the corrosion layers encountered on the Bugatti pipe. The stratum M is an aluminium alloy. Three CP strata have been identified. CP3 has a greyish mate color and is covering all of the corroded side of the pipe. Scattered over this uniform layer, blue-green (CP2) and white (CP1) spots of corrosion products can be found.

Fig. 5: Stratigraphic representation of the Bugatti water pipe under binocular using the MiCorr application. The characteristics of the strata are only accessible by clicking on the drawing that redirects you to the search tool by stratigraphy representation. This representation can be compared to Fig. 4, Credit HE-Arc CR, E.Granget.

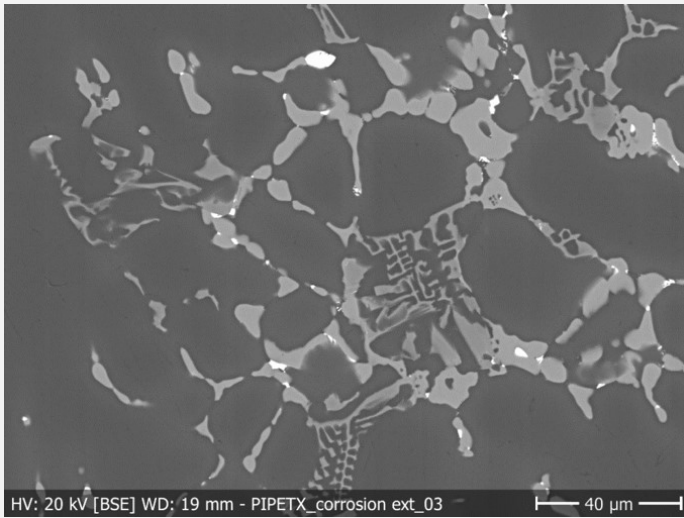
Fig. 11: Close-up image of Fig. 10,

Point analyses of the main dendritic phase showed that it is made of Al, Cu and Zn (Table 1 and Fig. 11). Elemental chemical distribution with EDS allowed to identified the following repartition (Fig. 12): Zn is uniformly present in the alloy. There are two interdendritic phases (Fig. 13): a eutectic phase containing Fe and Cu, and a second phase containing mostly Cu. Additionally Sn and Si precipitates could be identified.
