BUGATTI COOLING SYSTEM PIPE – AL ALLOY – FRANCE

Artefact name	Bugatti cooling system pipe
Authors	Granget, Elodie (, None) & . (MNAM (Musée National de l'Automobile de Mulhouse), Mulhouse, Alsace, France)
Url	/artefacts/670/

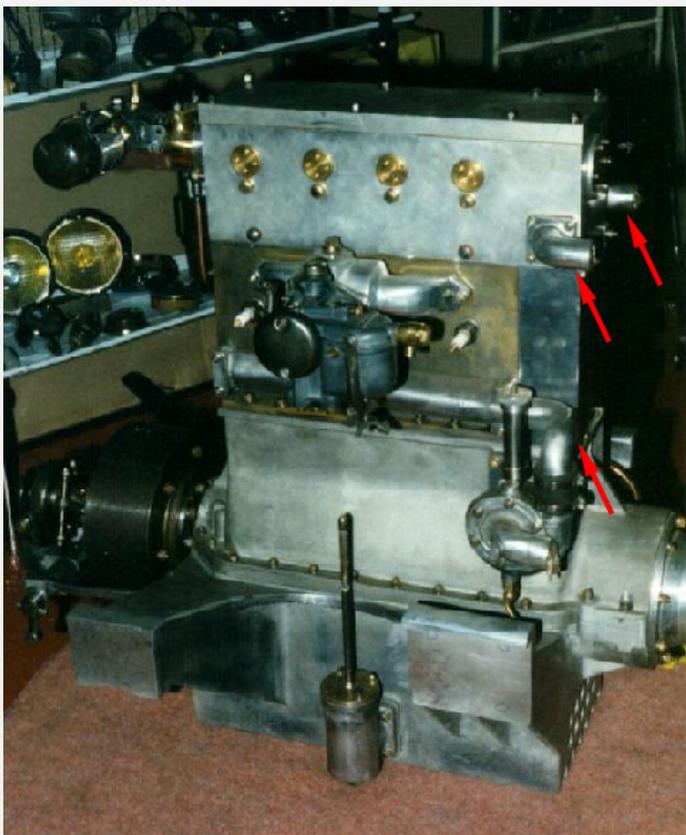
Fig. 2: Examples of water pipes located on a Type 37 engine,

A combustion engine transforms thermal energy into kinetic energy. This process is imperfect and releases a lot of heat through the block of the engine. Therefore, these parts need to be cooled down. A cooling system circulating water between the block [hot] and a heat exchanger (or radiator) [cold] is frequently used to fulfill this function (Poulain, 1995, p.86). Most of the time, the Bugatti inline cylinder engines have aluminium water pipes entering the block from below and exiting it from above, as shown on Fig.2.

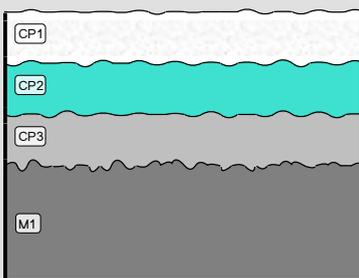
MiCorr stratigraphy(ies) – Bi

The schematic representation below gives an overview of the corrosion layers encountered on the Bugatti pipe. The stratum M is an aluminium alloy. Three CP strata have been identified. CP3 has a greyish mate color and is covering all of the corroded side of the pipe. Scattered over this uniform layer, blue-green (CP2) and white (CP1) spots of corrosion products can be found.

Fig. 5: Stratigraphic representation of the Bugatti water pipe under binocular using the MiCorr application. The characteristics of the strata are only accessible by clicking on the drawing that redirects you to the search tool by stratigraphy representation. This representation can be compared to Fig. 4, Credit HE-Arc CR, E.Granget.
