BUGATTI COOLING SYSTEM PIPE – AL ALLOY – FRANCE

Artefact name Bugatti cooling system pipe

Authors Granget. Elodie (, None) & . (MNAM (Musée National de l'Automobile de Mulhouse), Mulhouse, Alsace, France)

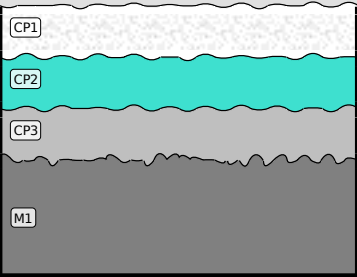
The schematic representation below gives an overview of the corrosion layers encountered on the Bugatti pipe. The stratum M is an aluminium alloy. Three CP strata have been identified. CP3 has a greyish mate color and is covering all of the corroded side of the pipe. Scattered over this uniform layer, blue-green (CP2) and white (CP1) spots of corrosion products can be found.

Fig. 5: Stratigraphic representation of the Bugatti water pipe under binocular using the MiCorr application. The characteristics of the strata are only accessible by clicking on the drawing that redirects you to the search tool by stratigraphy representation. This representation can be compared to Fig. 4, Credit HE-Arc CR, E.Granget.
