BUGATTI COOLING SYSTEM PIPE – AL ALLOY – FRANCE

Artefact name Bugatti cooling system pipe

Authors Granget. Elodie (, None) & . (MNAM (Musée National de l'Automobile de Mulhouse), Mulhouse, Alsace, France)

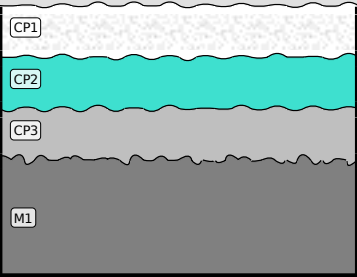
Fig. 5: Stratigraphic representation of the Bugatti water pipe under binocular using the MiCorr application. The characteristics of the strata are only accessible by clicking on the drawing that redirects you to the search tool by stratigraphy representation. This representation can be compared to Fig. 4, Credit HE-Arc CR, E.Granget.

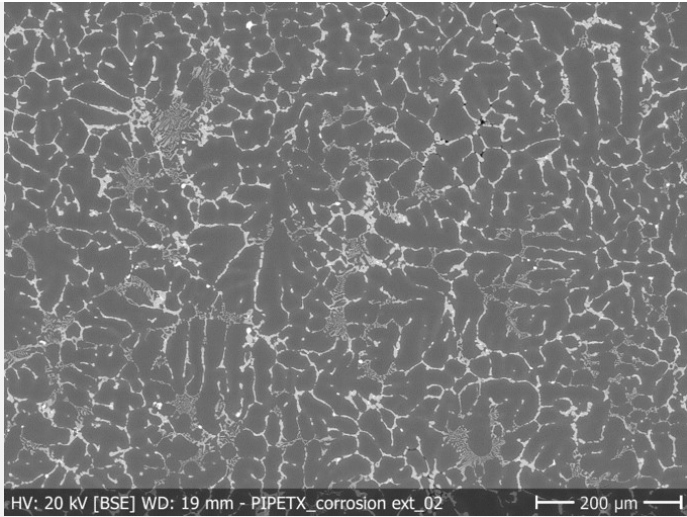
The metal is slightly porous (Fig. 8, red circles). Its dendritic microstructure is revealed by observation in bright field (Fig. 9) and with SEM (Fig. 10).

Fig. 8: Micrograph of the selected area shown on Fig.6 (rotated by 90°), unetched, dark field with indication of pores (red circles),

The BF and DF images (Figs. 8 and 9) show a few big cracks at the interface between CM1 and M1. The SEM image shows that they expand in a network of additional microcracks (Fig. 14). The pipe suffers from a uniform interdendritic corrosion. The Al, Cu and Zn phase is oxidising preferentially, developing then aluminium oxides, versus the interdendritic phases. In some places, pits of corrosion formed. SEM cartography showed a concentration of Cl at the base of the pit (Fig. 14: Green).

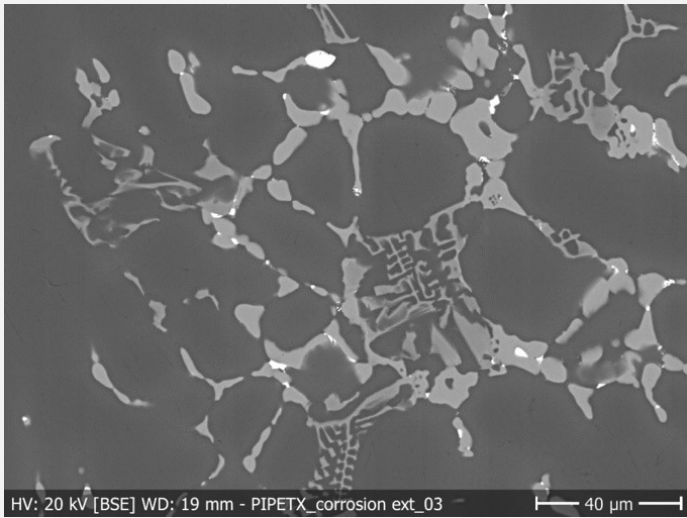
Fig. 9: Micrograph similar to Fig. 8, unetched, bright field showing the locations of Fig. 10 (in red) and Fig. 11 (in blue),

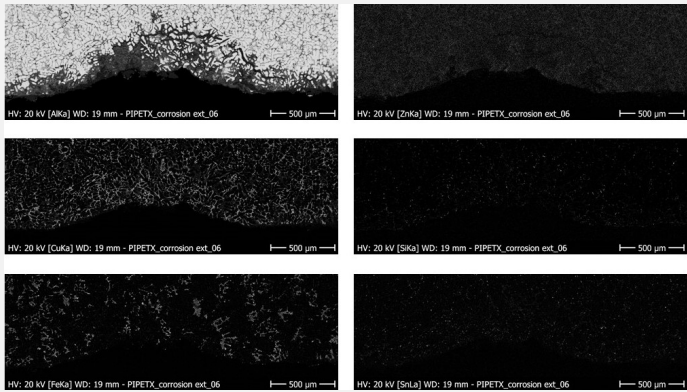
Fig. 10: SEM image (BSE mode) of the metal sample from Fig. 9 showing the microstructure of the pipe. Dark grey = main phase (Al), medium grey = interdendritic phase 1 (eutectic Fe, Cu), light grey = interdendritic phase 2 (Cu) and white = precipitates (Si, Sn),

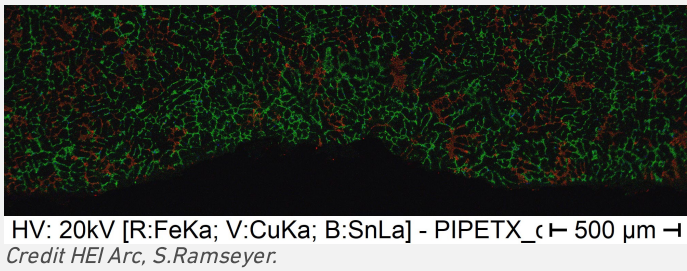
Point analyses of the main dendritic phase showed that it is made of Al, Cu and Zn (Table 1 and Fig. 11). Elemental chemical distribution with EDS allowed to identified the following repartition (Fig. 12): Zn is uniformly present in the alloy. There are two interdendritic phases (Fig. 13): a eutectic phase containing Fe and Cu, and a second phase containing mostly Cu. Additionally Sn and Si precipitates could be identified.

Fig. 11: Close-up image of Fig. 10,
