LEAD CAMES OF A STAINED GLASS WINDOW 52583 – AL ALLOY – SWITZERLAND

Artefact name Lead comes of a stained glass window 52583

Authors Alice Gerber. (Haute École Arc Neuchâtel, Neuchâtel, Neuchâtel, Switzerland)

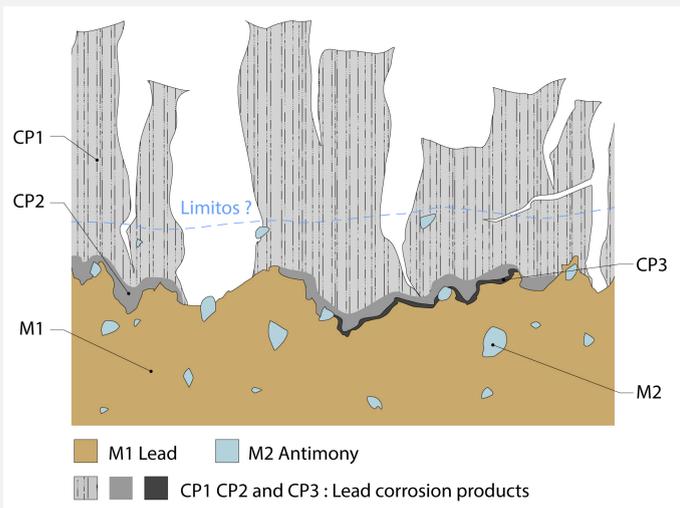
Visual description of the corrosion: Voluminous forms of corrosion, white powdery efflorescence can be observed. The schematic representation (Fig. 6) gives an overview of the corrosion layers encountered on the object from a first visual macroscopic observation.

Fig. 5: Stratigraphic representation of a corroded lead came by microscopic observation,

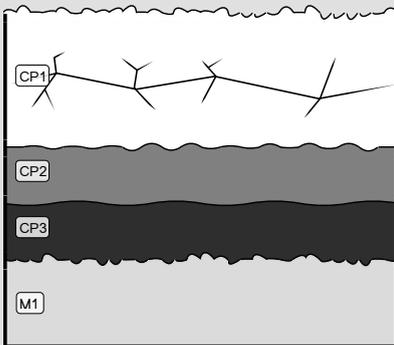
Fig. 6: Stratigraphic representation of the lead came under binocular using the MiCorr application with reference to Fig. 5. The characteristics of the strata are only accessible by clicking on the drawing that redirects you to the search tool by stratigraphy representation, Credit HE-Arc CR, A.Gerber.

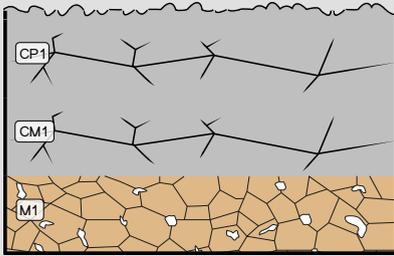
CP1 seems to be a heterogeneous compound as indicated on Fig. 10. But EDX analyses do not indicate a significant difference in composition. The attack of lead by organic acids causes the formation of salts, such as lead acetate which are then transformed into basic lead carbonates by the action of CO₂ from the environment as indicated by FTIR analysis of CP1.

Corrosion develops specifically on cams made of a lead-antimony alloy, where antimony inclusions constitute the cathode (0.150 V/SHE) versus lead (-0.125 V/SHE) which corrodes as an anode in presence of lead acetate (the electrolyte).

The limit of the original surface lies somewhere in the corrosion layers. Antimony nodules are inferior markers of the limit of the original surface.

Fig. 9: Stratigraphic representation of the lead came in cross-section (dark field) using the MiCorr application with reference to Figs. 7 and 10. The characteristics of the strata are only accessible by clicking on the drawing that redirects you to the search tool by stratigraphy representation, Credit HE-Arc CR, A.Gerber
