# LEAD CAMES OF A STAINED GLASS WINDOW 52583 – AL ALLOY – SWITZERLAND

**Artefact name** Lead comes of a stained glass window 52583

**Authors** Alice Gerber. (Haute École Arc Neuchâtel, Neuchâtel, Neuchâtel, Switzerland)

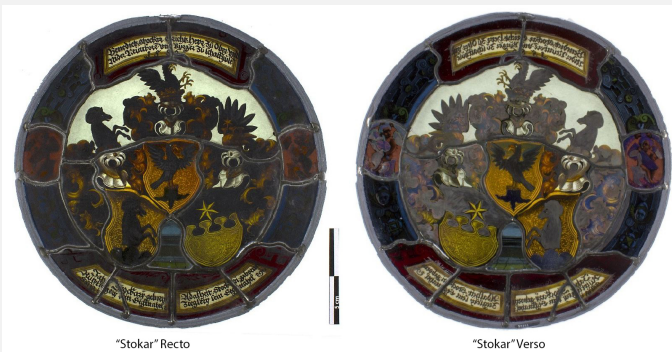
Fig. 1: Stained glass panel "Stokar" both sides,

The study of this object is based on a simple problematic: in 2009 two stained glass panels were placed in a showcase for a permanent exhibition, the lead came were then in a good conservation condition. In 2018, the lead showed voluminous efflorescence of white, powdery corrosion products.

The environment of this showcase contained a high level of acetic acid. Lead being sensitive to organic acids, it corroded strongly. This is not new, but what is interesting here is that the two objects corroded in a very heterogeneous way. One lead cam may be deformed and completely covered with bulky white efflorescences, and the one next to it shows no corrosion.

The "stokar" window, which is of interest here, was restored in 2008, just before it was put on display. The restoration consisted of replacing some of the lead cams. Thus, while the object is dated to the 16th century, the replaced cams were new when they entered the display case. In 2018, they were completely corroded. In comparison, the other stained glass panel, with older lead cams, was placed in the same display case at the same time. For this second panel, the cams are slightly corroded in 2018, but not as badly as those of the 'Stokar' panel. The metal chosen by the restorer reacted more strongly with the corrosive environment (the display case) than the historical metal.
