LEAD CAMES OF A STAINED GLASS WINDOW 52583 – AL ALLOY – SWITZERLAND

Artefact name Lead comes of a stained glass window 52583

Authors Alice Gerber. (Haute École Arc Neuchâtel, Neuchâtel, Neuchâtel, Switzerland)

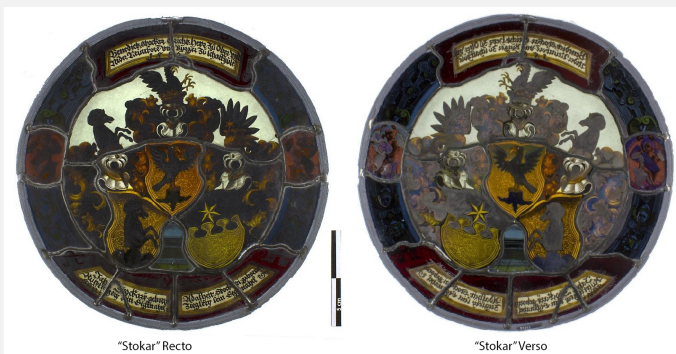
Fig. 1: Stained glass panel "Stokar" both sides,

The study of this object is based on a simple problematic: in 2009 two stained glass panels were placed in a showcase for a permanent exhibition, the lead came were then in a good conservation condition. In 2018, the lead showed voluminous efflorescence of white, powdery corrosion products.

The environment of this showcase contained a high level of acetic acid. Lead being sensitive to organic acids, it corroded strongly. This is not new, but what is interesting here is that the two objects corroded in a very heterogeneous way. One lead cam may be deformed and completely covered with bulky white efflorescences, and the one next to it shows no corrosion.

The "stokar" window, which is of interest here, was restored in 2008, just before it was put on display. The restoration consisted of replacing some of the lead cams. Thus, while the object is dated to the 16th century, the replaced cams were new when they entered the display case. In 2018, they were completely corroded. In comparison, the other stained glass panel, with older lead cams, was placed in the same display case at the same time. For this second panel, the cams are slightly corroded in 2018, but not as badly as those of the 'Stokar' panel. The metal chosen by the restorer reacted more strongly with the corrosive environment (the display case) than the historical metal.
