LEAD CAMES OF A STAINED GLASS WINDOW 52583 – AL ALLOY – SWITZERLAND

Artefact name Lead comes of a stained glass window 52583

Authors Alice Gerber. (Haute École Arc Neuchâtel, Neuchâtel, Neuchâtel, Switzerland)

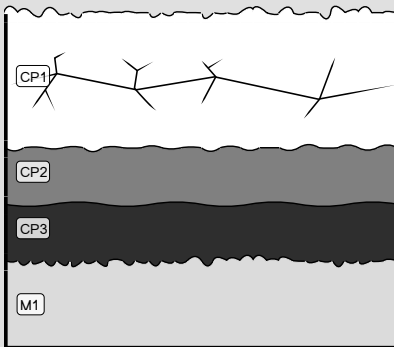
Visual description of the corrosion: Voluminous forms of corrosion, white powdery efflorescence can be observed. The schematic representation (Fig. 6) gives an overview of the corrosion layers encountered on the object from a first visual macroscopic observation.

Fig. 6: Stratigraphic representation of the lead came under binocular using the MiCorr application with reference to Fig. 5. The characteristics of the strata are only accessible by clicking on the drawing that redirects you to the search tool by stratigraphy representation, Credit HE-Arc CR, A.Gerber.

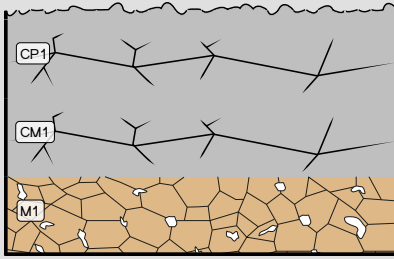
For this lead cam, the alloy used is a lead alloy with about 1.5% antimony. Under a microscope, the alloy is not homogeneous. The antimony has formed nodules in the alloy, which are visible both under an optical microscope and under SEM. The cross-section shows that corrosion does not attack the antimony nodules in the alloy, it progresses by mineralizing the lead around these nodules.

CP1 seems to be a heterogeneous compound as indicated on Fig. 10. But EDX analyses do not indicate a significant difference in composition. The attack of lead by organic acids causes the formation of salts, such as lead acetate which are then transformed into basic lead carbonates by the action of CO₂ from the environment as indicated by FTIR analysis of CP1.

The limit of the original surface lies somewhere in the corrosion layers. Antimony nodules are inferior markers of the limit of the original surface.

Fig. 9: Stratigraphic representation of the lead came in cross-section (dark field) using the MiCorr application with reference to Figs. 7 and 10. The characteristics of the strata are only accessible by clicking on the drawing that redirects you to the search tool by stratigraphy representation, Credit HE-Arc CR, A.Gerber
