LEAD CAMES OF A STAINED GLASS WINDOW 52583 – AL ALLOY – SWITZERLAND

Artefact name Lead comes of a stained glass window 52583

Authors Alice Gerber. (Haute École Arc Neuchâtel, Neuchâtel, Neuchâtel, Switzerland)

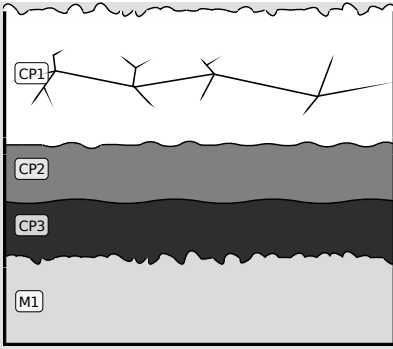
Visual description of the corrosion: Voluminous forms of corrosion, white powdery efflorescence can be observed.

The schematic representation (Fig. 6) gives an overview of the corrosion layers encountered on the object from a first visual macroscopic observation.

Fig. 6: Stratigraphic representation of the lead came under binocular using the MiCorr application with reference to Fig. 5. The characteristics of the strata are only accessible by clicking on the drawing that redirects you to the search tool by stratigraphy representation, Credit HE-Arc CR, A.Gerber.

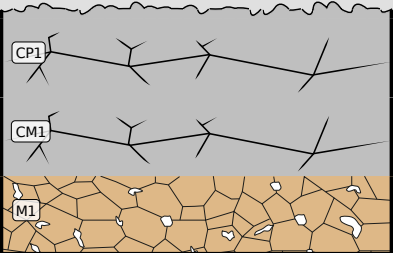
CP1 seems to be an heterogeneous compound as indicated on Fig. 10. But EDX analyses do not indicate a significant difference in composition. The attack of lead by organic acids causes the formation of salts, such as lead acetate which are then transformed into basic lead carbonates by the action of CO2 from the environment as indicated by FTIR analysis of CP1.

Corrosion develops specifically on cams made of a lead-antimony alloy, where antimony inclusions constitute the cathode (0.150 V/SHE) versus lead (-0.125 V/SHE) which corrodes as an anode in presence of lead acetate (the electrolyte).

Fig. 9: Stratigraphic representation of the lead came in cross-section (dark field) using the MiCorr application with reference to Figs. 7 and 10. The characteristics of the strata are only accessible by clicking on the drawing that redirects you to the search tool by stratigraphy representation, Credit HE-Arc CR, A.Gerber

Heterogeneous active corrosion on lead cams. The tin content of the alloy indicates whether or not a cam will corrode ; with a low tin content lead is likely to corrode more. In a lead-antimony alloy, corrosion preferentially attacks the lead.
