# LEAD CAMES OF A STAINED GLASS WINDOW 52583 – AL ALLOY – SWITZERLAND

**Artefact name** Lead comes of a stained glass window 52583

**Authors** Alice Gerber. (Haute École Arc Neuchâtel, Neuchâtel, Neuchâtel, Switzerland)

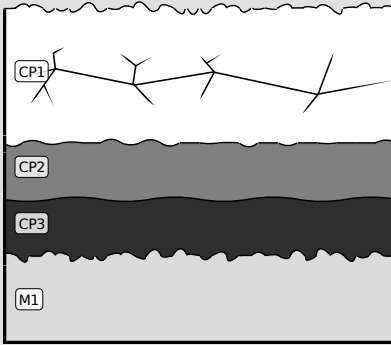
Visual description of the corrosion: Voluminous forms of corrosion, white powdery efflorescence can be observed.

The schematic representation (Fig. 6) gives an overview of the corrosion layers encountered on the object from a first visual macroscopic observation.

Fig. 6: Stratigraphic representation of the lead came under binocular using the MiCorr application with reference to Fig. 5. The characteristics of the strata are only accessible by clicking on the drawing that redirects you to the search tool by stratigraphy representation, Credit HE-Arc CR, A.Gerber.

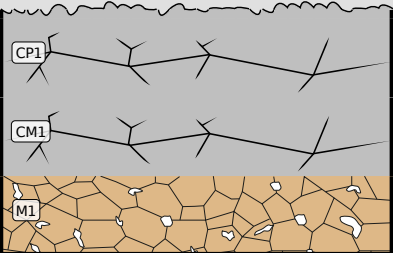
CP1 seems to be an heterogeneous compound as indicated on Fig. 10. But EDX analyses do not indicate a significant difference in composition. The attack of lead by organic acids causes the formation of salts, such as lead acetate which are then transformed into basic lead carbonates by the action of CO2 from the environment as indicated by FTIR analysis of CP1.

Corrosion develops specifically on cams made of a lead-antimony alloy, where antimony inclusions constitute the cathode (0.150 V/SHE) versus lead (-0.125 V/SHE) which corrodes as an anode in presence of lead acetate (the electrolyte).

The limit of the original surface lies somewhere in the corrosion layers. Antimony nodules are inferior markers of the limit of the original surface.

Corrosion form	Uniform - transgranular
Corrosion type	Active corrosion of lead

Fig. 9: Stratigraphic representation of the lead came in cross-section (dark field) using the MiCorr application with reference to Figs. 7 and 10. The characteristics of the strata are only accessible by clicking on the drawing that redirects you to the search tool by stratigraphy representation, Credit HE-Arc CR, A.Gerber
