SHINGLE OF A ROOF – CU ALLOY – MODERN TIMES – SWITZERLAND

Artefact name	Shingle of a roof
Authors	Marianne. Senn (EMPA, Dübendorf, Zurich, Switzerland) & Christian. Degriigny (HE-Arc CR, Neuchâtel, Neuchâtel, Switzerland)
Url	/artefacts/688/

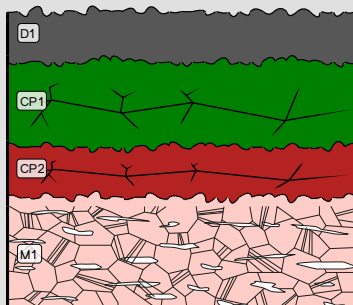
The corrosion crusts of the external and internal sides are distinctively different (Fig. 7). On the internal side an irregular red-orange corrosion layer has developed, and pitting corrosion has occurred. The more uniform corrosion layers on the external side are composed of a red-orange layer, followed by a thicker green outer layer. In some areas, dark-red corrosion products can be observed between the green and red-orange sub-layers. The same dark-red sub-layer can be seen in areas on the internal side covering the red-orange corrosion products. The red-orange corrosion layer on both sides (CP2) has a chemical composition similar to cuprite/ Cu_2O , while the green layer on the external side (CP1) contains Cu, S and O and is enriched on its upper surface with Si (Table 3 and Fig. 8). XRD analysis of the corrosion products on the external side of another shingle fragment from the same roof identified brochantite/ $\text{Cu}_4\text{SO}_4(\text{OH})_6$ and cuprite as corrosion products (Rapport d'analyse no. MAH 98-257). These results are confirmed by Raman spectroscopy of the external side of this sample where the same compounds were clearly identified (Figs. 9 and 10).

Fig. 9: Raman spectrum of the red-orange inner corrosion layer (CP2) of the external side (cat3_B) compared to a cuprite standard spectrum. Settings: laser wavelength 532nm, acquisition time 100s, one accumulation, filter D2 (0.75-0.8 mW), hole 500, slit 80, grating 600. Method of analysis: Raman spectroscopy, Lab Swiss National Museum, Affoltern a. Albis ZH,

Fig. 10: Raman spectrum of the green outer corrosion layer (CP1) of the external side (cat3_H) compared to a brochantite standard spectrum. Settings: laser wavelength 532nm, acquisition time 100s, one accumulation, filter D2 (0.75-0.8 mW), hole 500, slit 80, grating 600. The peak indicated with an arrow on the cat3_H spectrum is due to fluorescence. Method of analysis: Raman spectroscopy, Lab Swiss National Museum, Affoltern a. Albis ZH,
