TANG FRAGMENT OF A KNIFE HR-6246 - TIN BRONZE - LATE BRONZE AGE - SWITZERLAND

Artefact name	Tang fragment of a knife HR-6246
Authors	Marianne. Senn (EMPA, Dübendorf, Zurich, Switzerland) & Christian. Degriigny (HE-Arc CR, Neuchâtel, Neuchâtel, Switzerland)
Url	/artefacts/690/

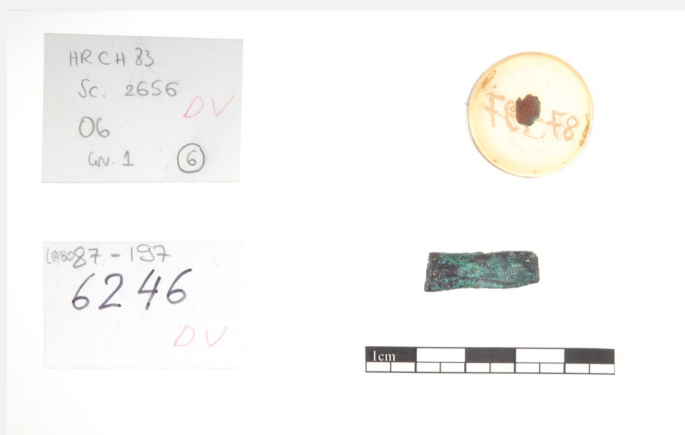
Fig. 5: Cross-section of the tang and remaining material,

Description of sample	The cross-section corresponds to a lateral cut (Fig. 4). The surface is covered with a thick corrosion crust (Fig. 8).
Alloy	Tin Bronze
Technology	Cold worked after annealing
Lab number of sample	MAH 87-197
Sample location	Musées d'art et d'histoire, Genève, Geneva
Responsible institution	Musées d'art et d'histoire, Genève, Geneva
Date and aim of sampling	1987, metallography and corrosion characterisation

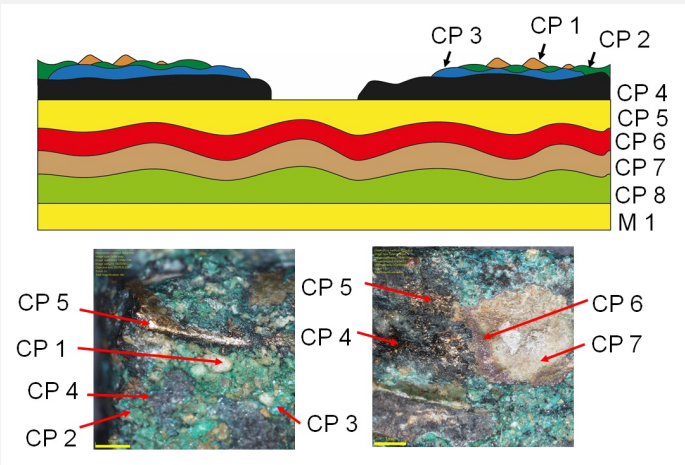
Fig. 6: Stratigraphic representation of the tang fragment under binocular and location of the strata,

The schematic representation below gives an overview of the corrosion layers encountered on the tang from a first visual macroscopic observation.

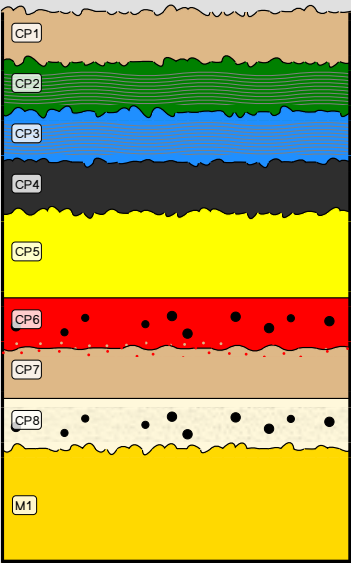
Fig. 7: Stratigraphic representation of the tang fragment under binocular using the MiCorr application. The characteristics of the strata are only accessible by clicking on the drawing that redirects you to the search tool by stratigraphy representation, Credit HE-Arc CR.

Corrosion products CP2 to CP5 observed under binocular corresponds to CP1 to CP4 under cross-section. Other CPs are more difficult to compare.
